Country Case Study: Wakashio Oil Spill in Mauritius

Module 7

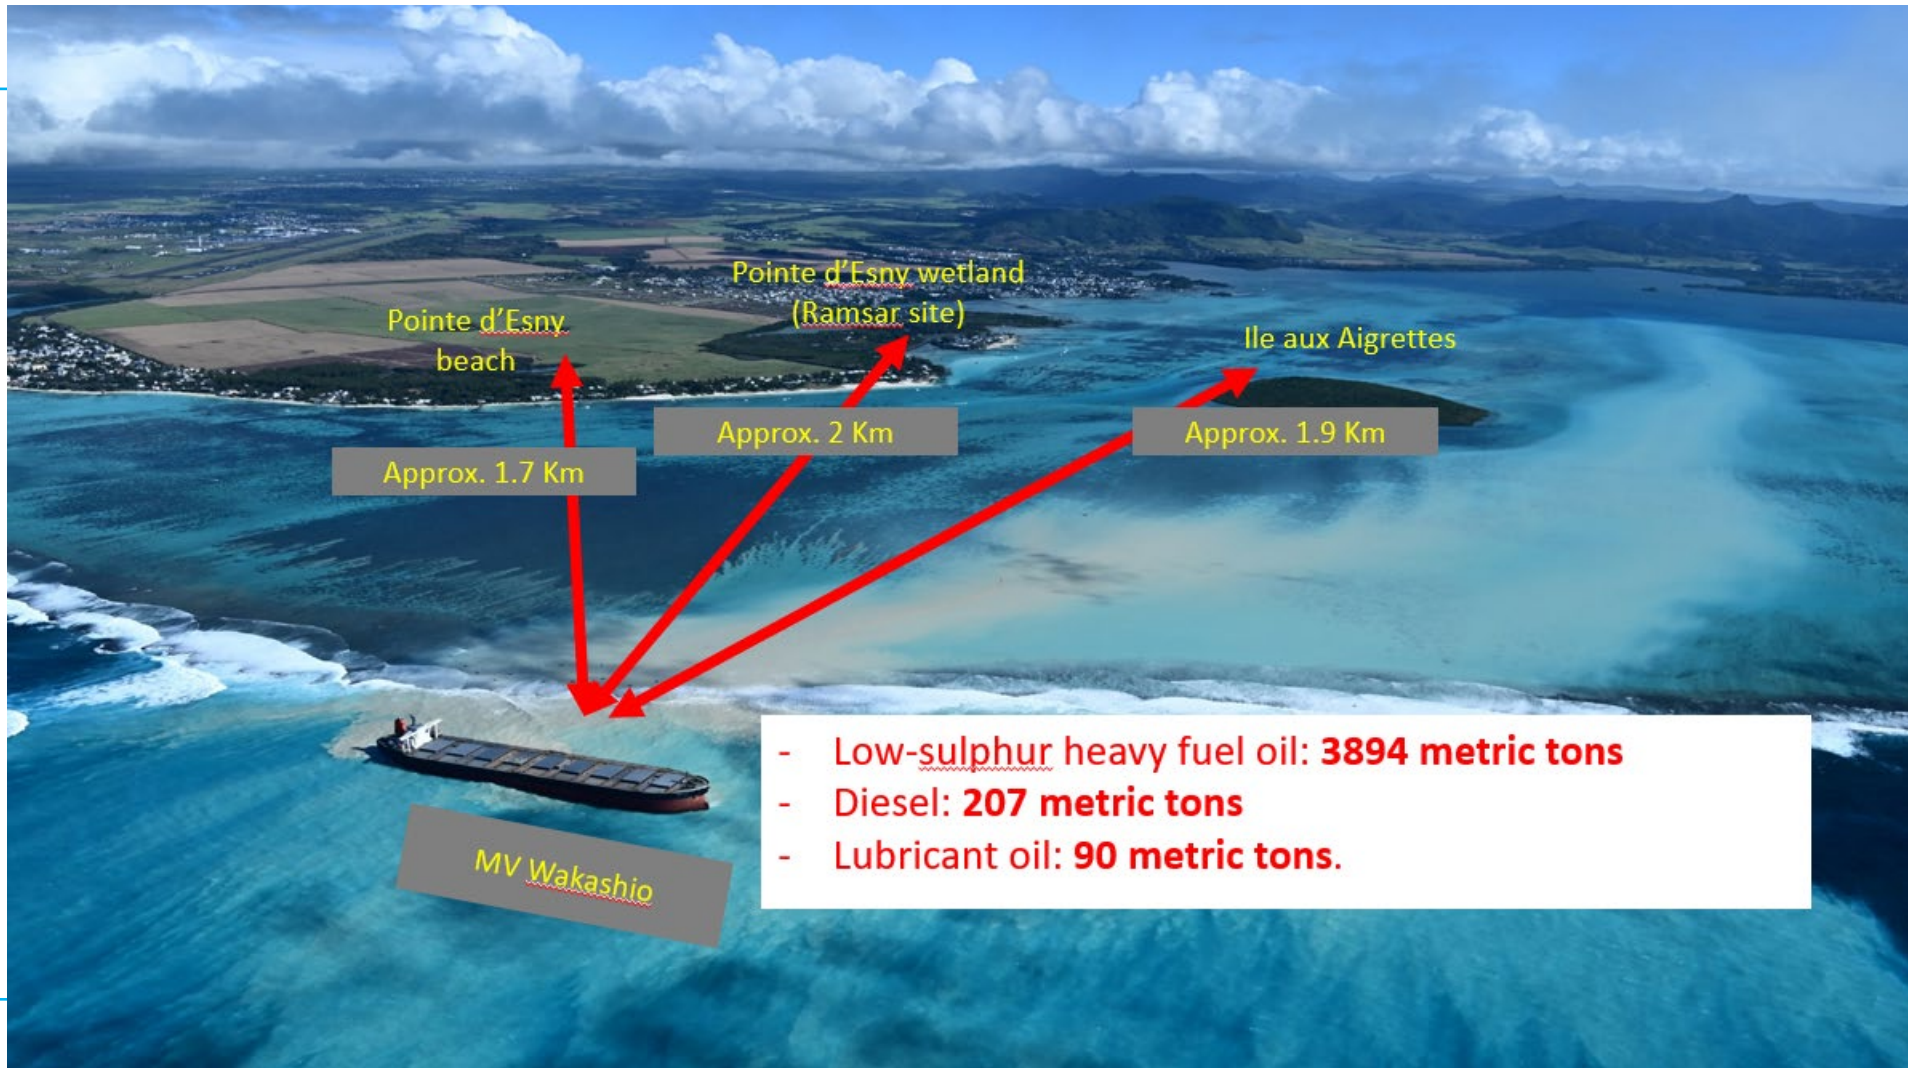
25 July 2020: Grounding of MV Wakashio

No oil spill was observed at that time.

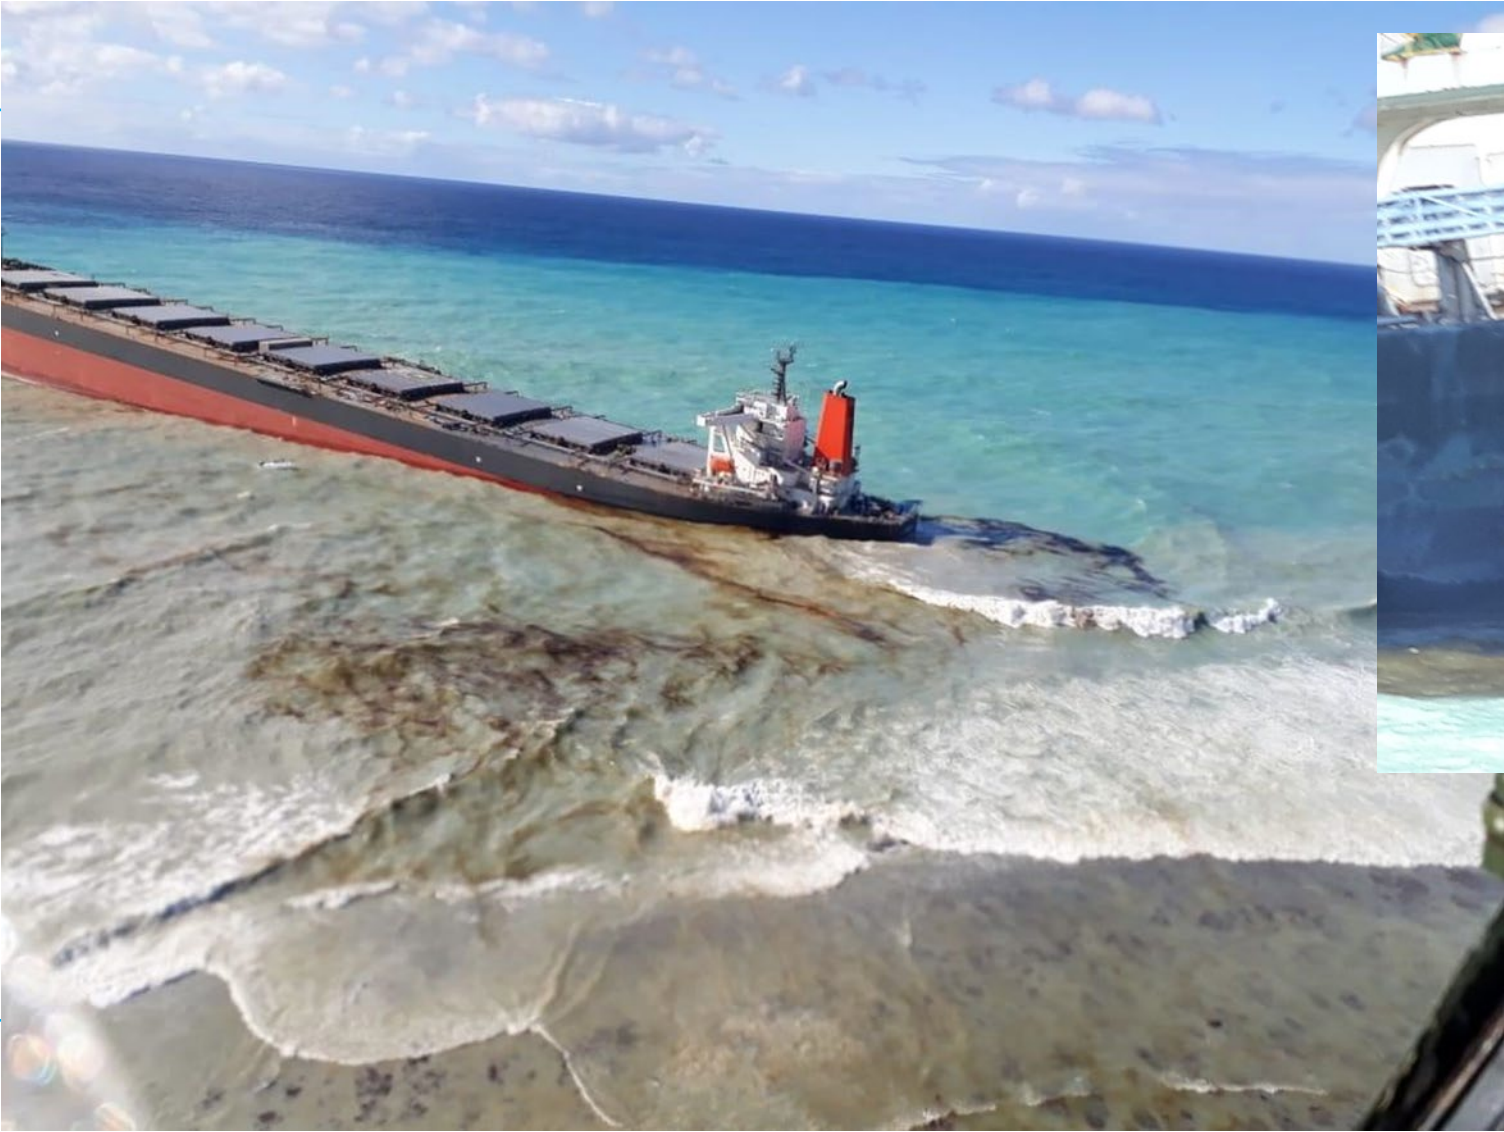
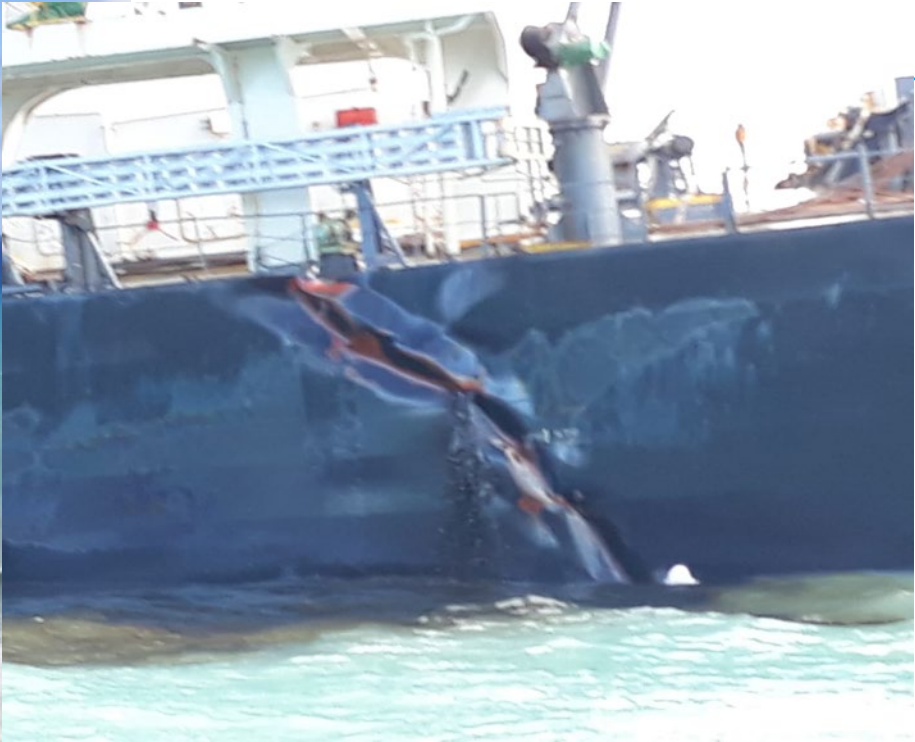
06 August 2020: Oil spill occurred from MV Wakashio

Around 841 tons of LSFO spilled out

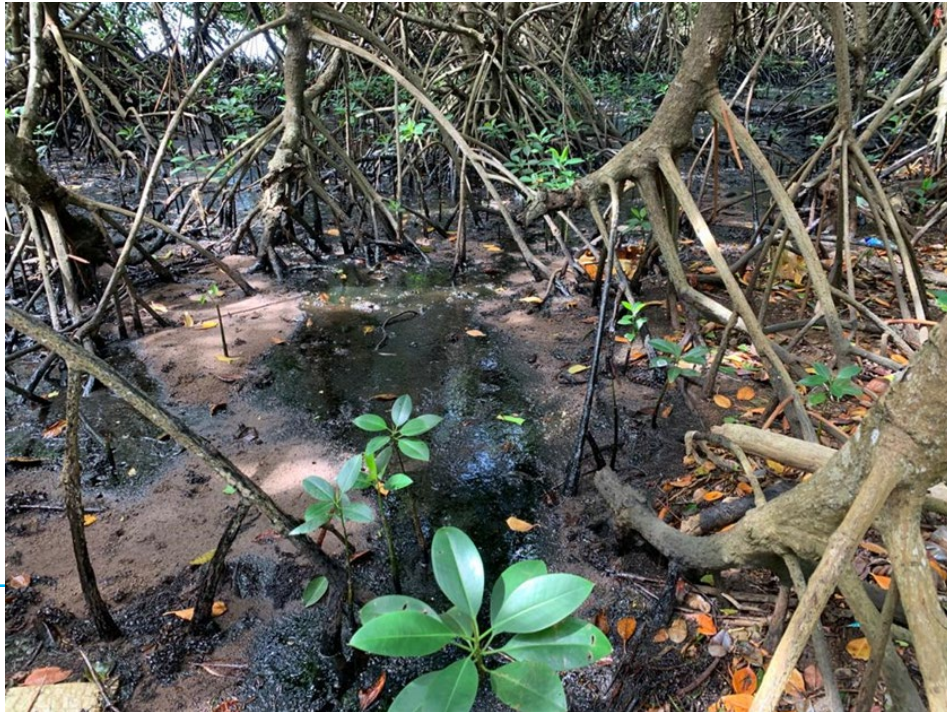
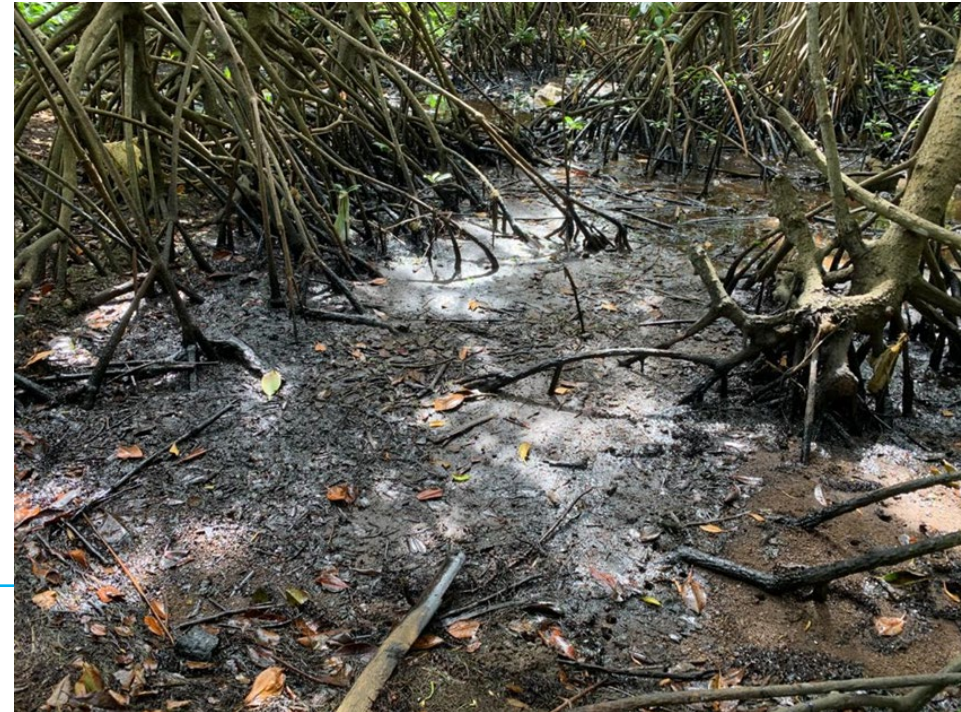
(i) Fringe mangrove: Mangrove dominates most contaminated sites within the affected area. This ecologically sensitive habitat was typically found in the form of a relatively narrow fringe on the lower and mid-shore. The sites were sheltered, with a substrate of mud, sand, and scattered basalt boulders in places.

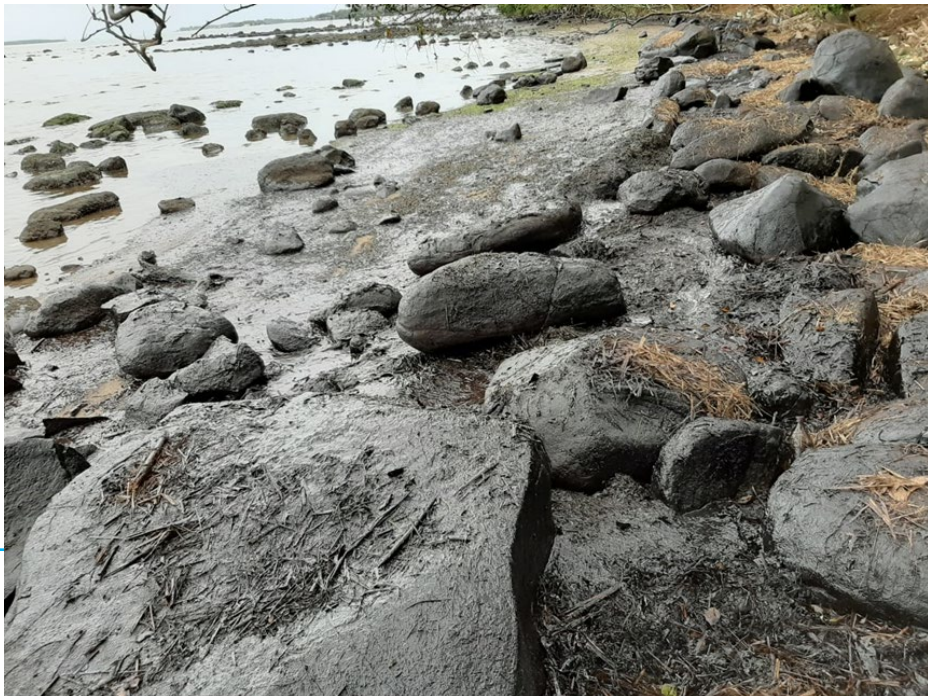
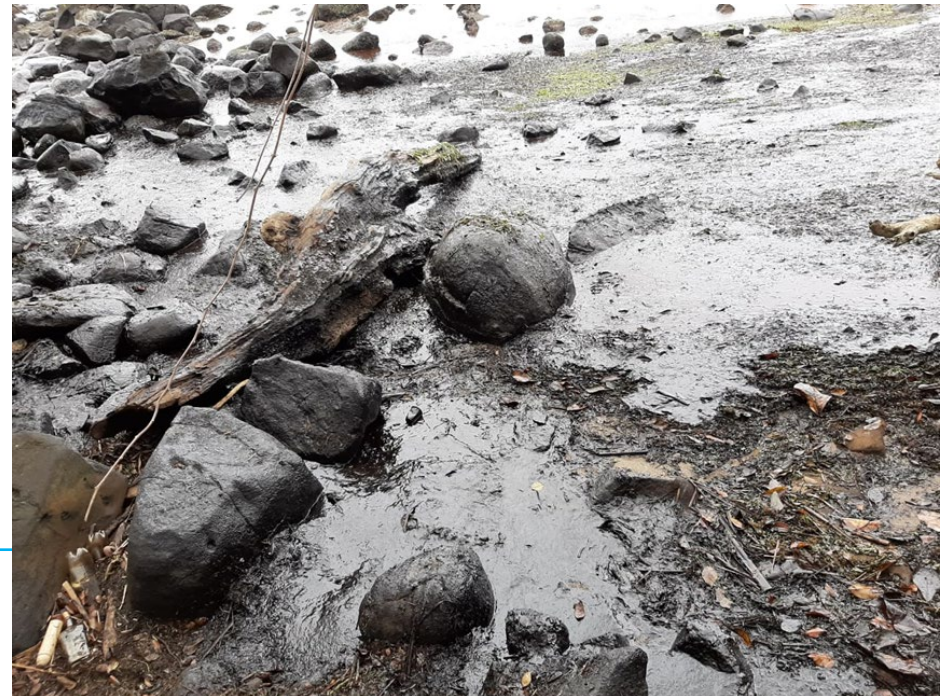
- (ii) Rocky shore: Rocky shores were frequently encountered within the affected area. These sites were typically sheltered, and the rocky substrate was usually in the form of large basalt boulders, often interspersed with dark volcanic sand. Rock surfaces were found to have coatings of oil, with some thicker accumulations in places.

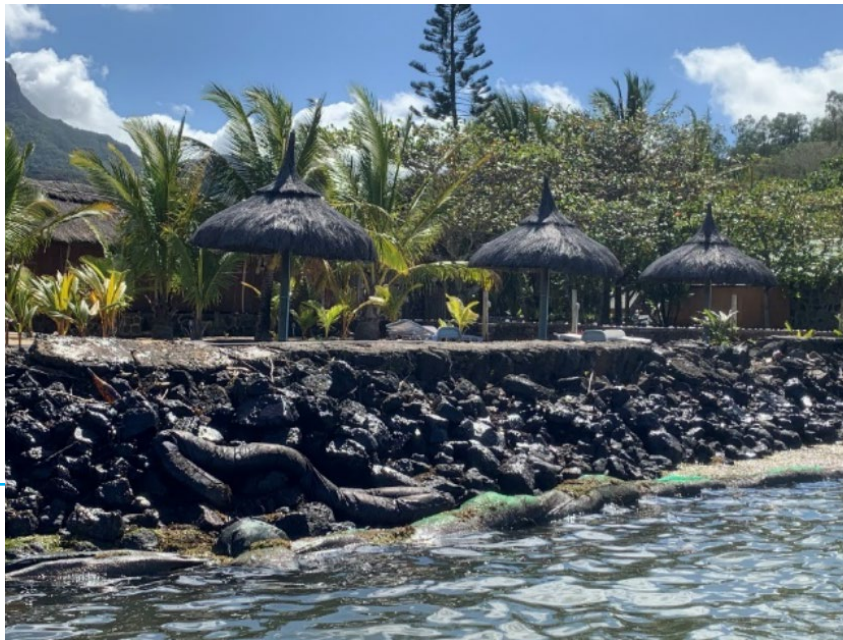
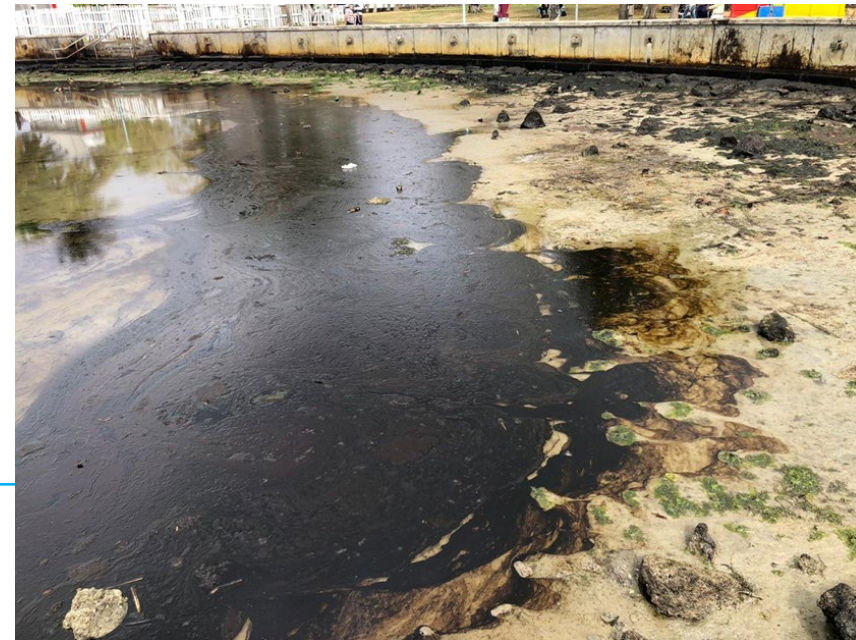
- (iii) Human-made structures: In addition to natural shorelines, there were also human-made features along the affected stretch of coastline. These included quay walls, piers, and boulder rip-rap. These sites typically had a defined band of oil contamination with accumulations in-between rocks, and other gaps, and oily debris scattered throughout.

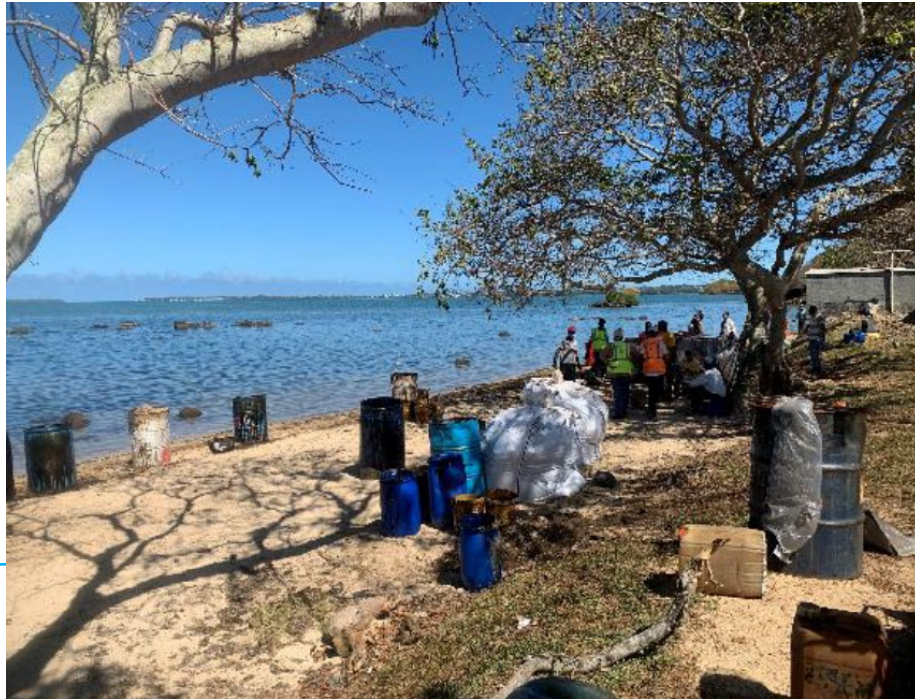
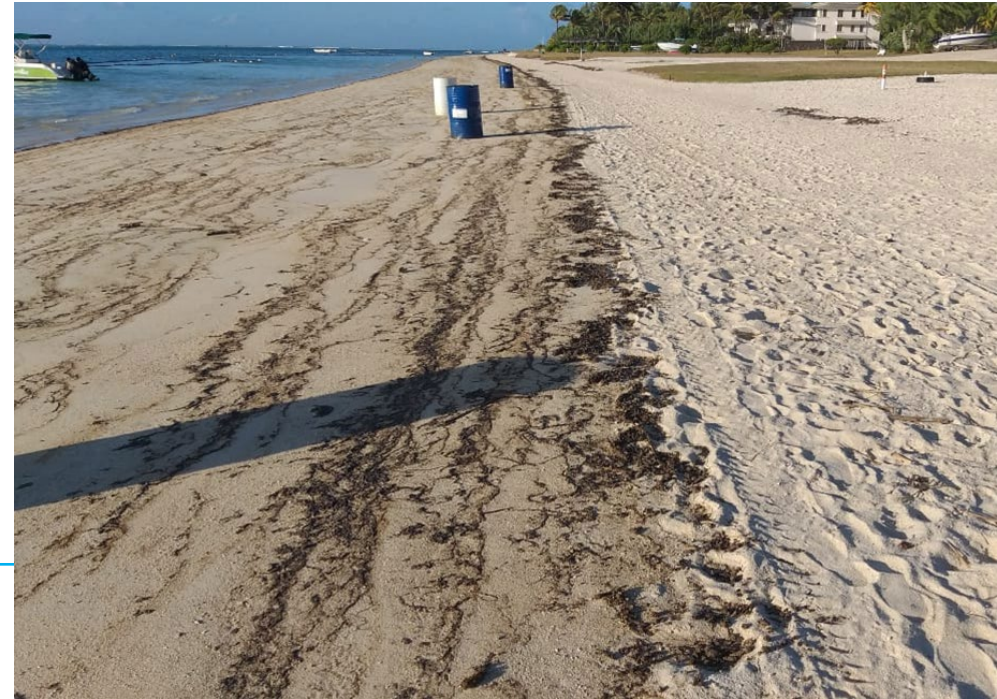
- (iv) Sand beaches: There were relatively few sand shores within the affected area, with the more heavily contaminated sites consisting of short stretches of sheltered narrow beach.
