# ***Guyana Floods***

## **Geotechnical and hydraulic assessment of the East Demerara Water Conservancy dam**

February 2005

**Joint UNEP/OCHA Environment  
Unit**

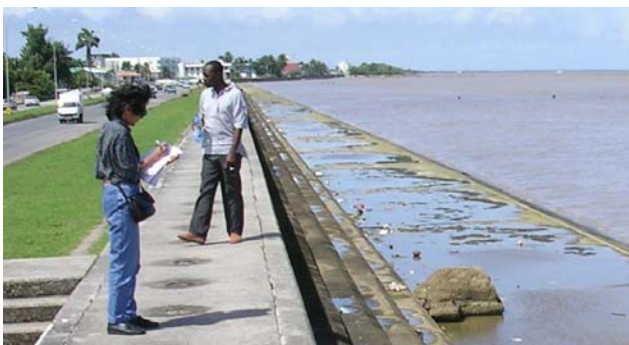
The seawall in Georgetown prospects the lower areas of the capital from the sea (I don’t understand use of PROSPECTS in this context)

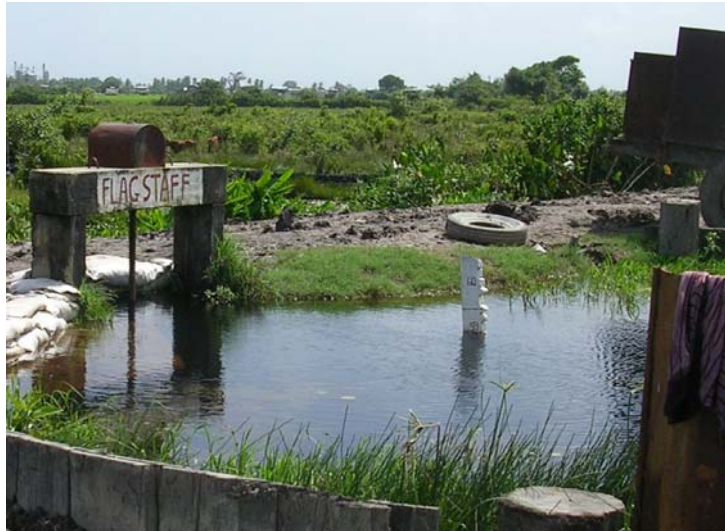
The gauge at Flag Staff on 6 February, reading 59.4 G.D., just inches below the top level of the dam

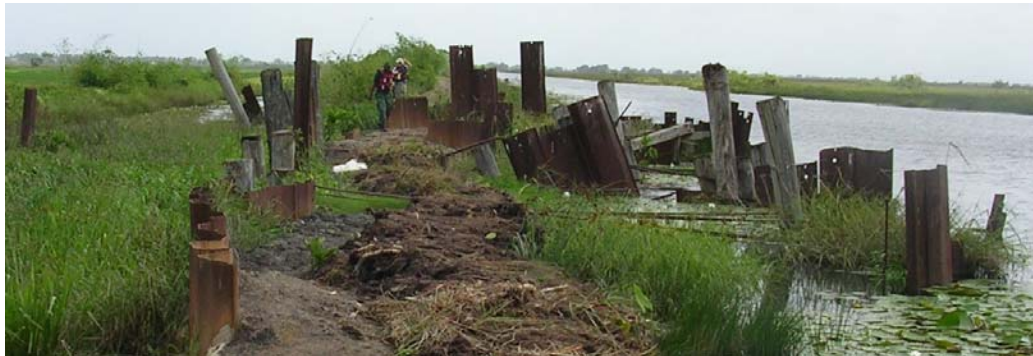
The EDWC-dam is a fragile construction, built on peat and clay soil layers, constructed out of the same material. The side slopes are very steep (up to 1:1). Crown widths varies from 1 to 5 feet. At several stretches the top actually consists of a row of clay-bags. Patchworks have been carried out in several places, covering ancient breaches or recent over toppings. At the eastern section of the northern dam, about 30% of the dam is in critical condition. For the rest of the northern dam and the western dam about 10% is in a poor state.

The state of the Conservancy dam is characterized by poor maintenance and patchwork and requires urgent repair

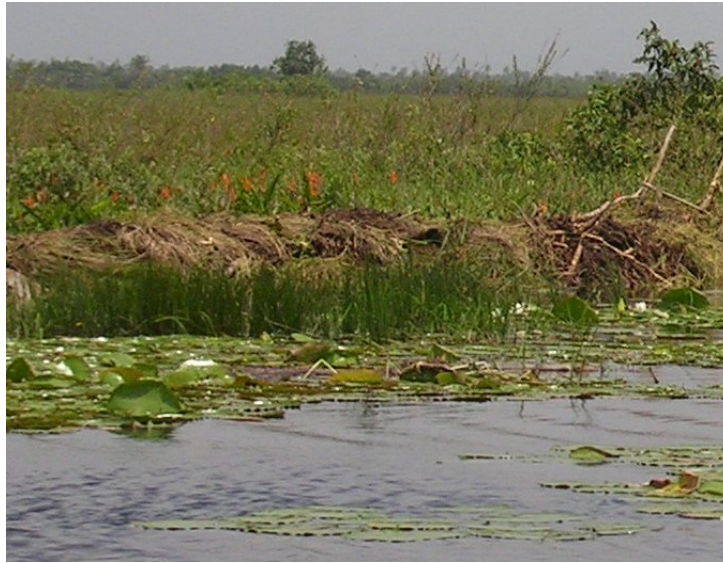
A typical waterside view at the conservancy dam (the peat ridge) with green wastelands behind it

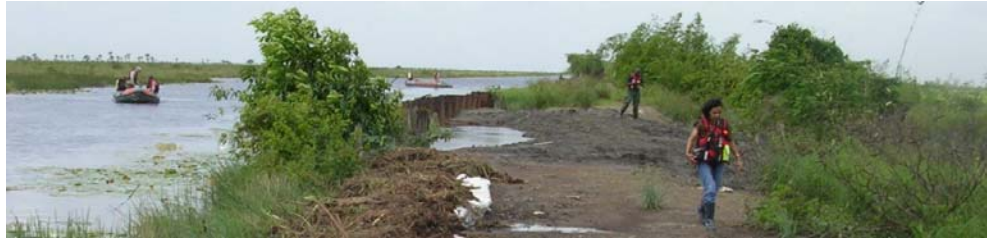
The dam, with at the conservancy swampland and at the right the coastal zone. White bags with clay and some peat are retaining the water. In the back an overtopping, sealed of with sheet piling works
