**Oil Spill Technical Report**  
Typhoon Haiyan/Yolanda  
Estancia, Iloilo Province, Philippines  
December 2013

JOINT  
**UNEP / OCHA**  
ENVIRONMENT UNIT

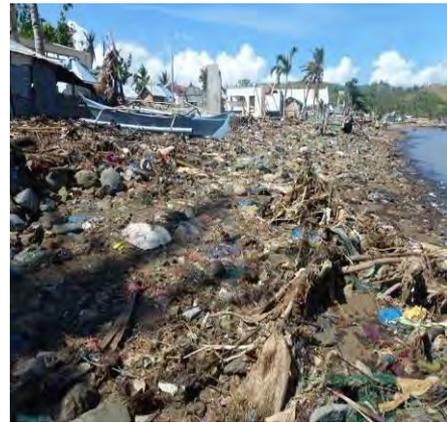
Debris from destroyed houses, Batad Barangay Alinsolong, Iloilo Province, December 2013

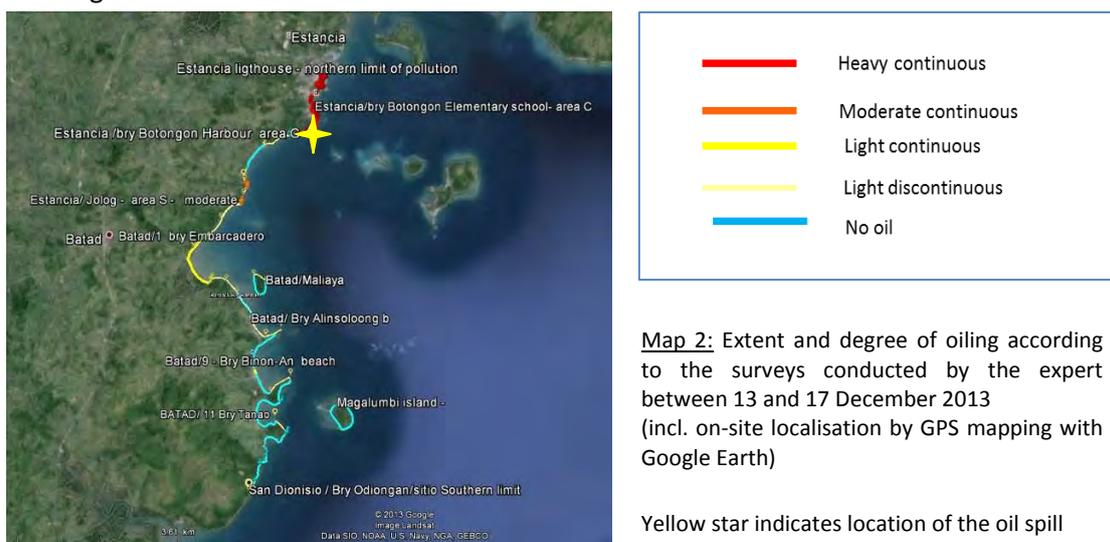
The most heavily oiled area of 1.5 to 2 km of shoreline was located in the town and Barangay Botongon of Estancia municipality, mostly to the north of the damaged barge and a few hundred meters south down to Da’an Banua. The rest of the affected area lay south of the damaged barge.

Two stretches of approximately a hundred meters of shoreline were moderately affected in Barangay Jolog (Estancia municipality). A lot of light contamination was scattered along the shoreline down to Barangay Odiongan (San Dionisio municipality). Within the total affected area (of approximately 10 km) some shoreline segments were not affected at all.

Above map illustrates the observed level of contamination of the shoreline prepared on Google Earth, based on GPS (Global Positioning System) data collected during the survey and indicating heavily oiled areas, moderately oiled areas, lightly oiled areas (continuously or not), and unaffected areas.

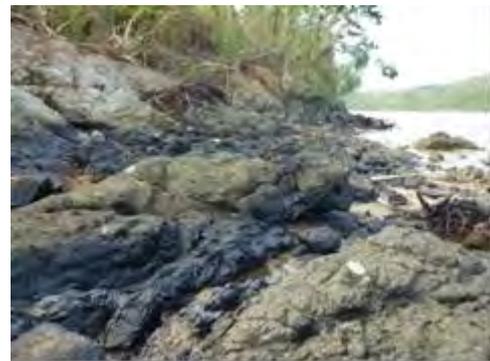
Natural clean-up: scattered oil pollution on a rocky shoreline in Batad being weathered, 19 December 2013

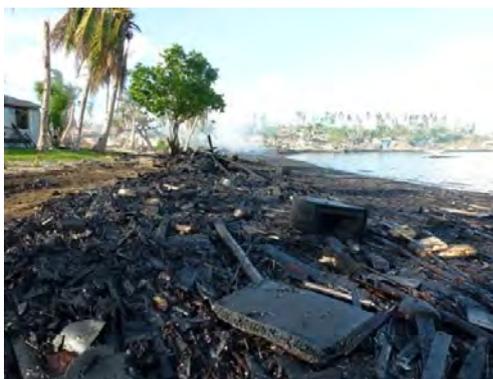
Debris on Estancia Matta Beach, 10 December 2013

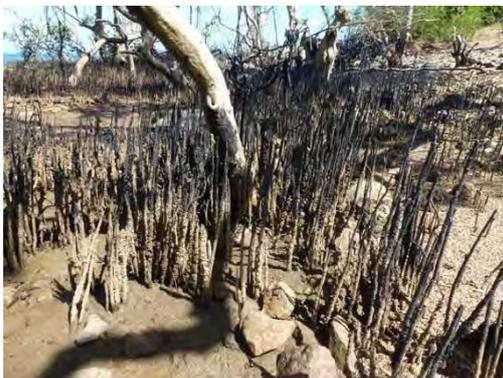
Weathered oil on Avicenia roots on Maliaya Island, 13 December 2013

As it is not possible to clean the roots and trunks (mechanically or by cleaning agent) without the cleaning action being more harmful to the trees, no clean-up action is recommended for the mangrove trees. The authorities' expert Dr Sadaba had regularly monitored the status of the mangroves, some of which are bearing new leaves.

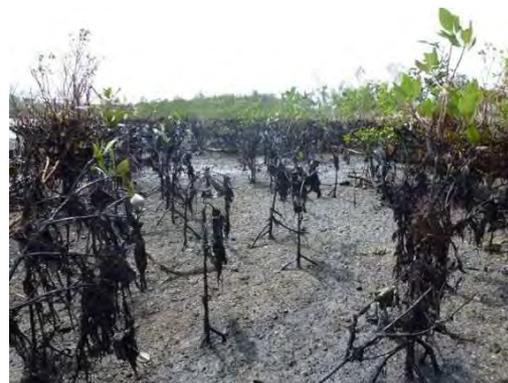
Lightly oiled mangrove shrubs in Batad /Embarcadero, 15 December 2013

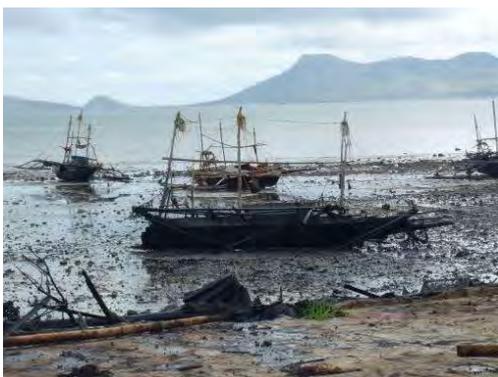
Damaged and oil-contaminated boats in Estancia, 8 December 2013

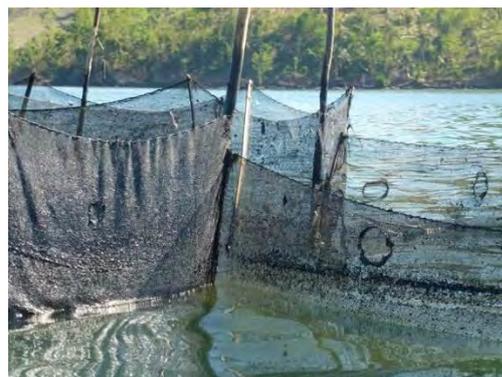
Oiled fixed nets (puenots) in Embarcadero, Batad, 18 December 2013

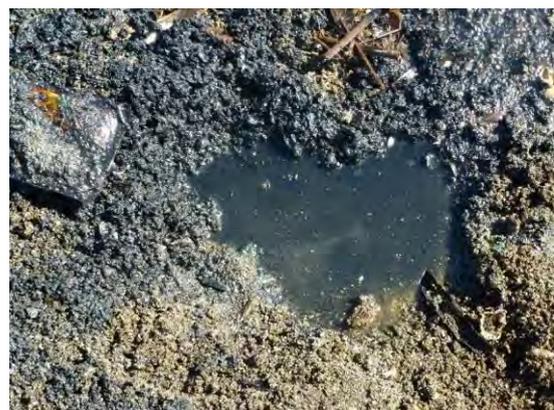
Black colour of sediment due to natural lack of oxygen in muddy sediment (anaerobiose)  
Embarcadero/Salong 17 December

muddy sediment and should not be confused with oil.

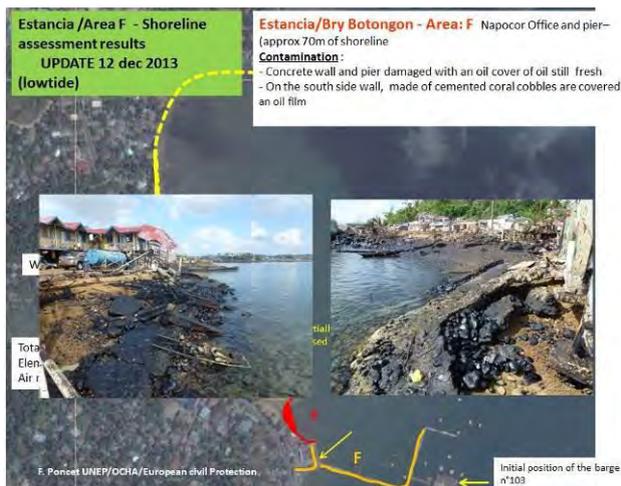
Area 5- detailed map, photos and level of contamination

Note : This area does not require deep cleaning if the concrete wall will be rebuilt on top of the existing wall

- Remove the accumulations of oil associated with the sorbent booms used for containment
- Use rice straw to accelerate the drying of residual oil and let them dry in the sun
