ENVIRONMENTAL ASSESSMENT

Flooding in the Gaza Province, Limpopo River Basin, Mozambique

Environmental Assessment of Flooding in Gaza province, Limpopo river basin, Mozambique

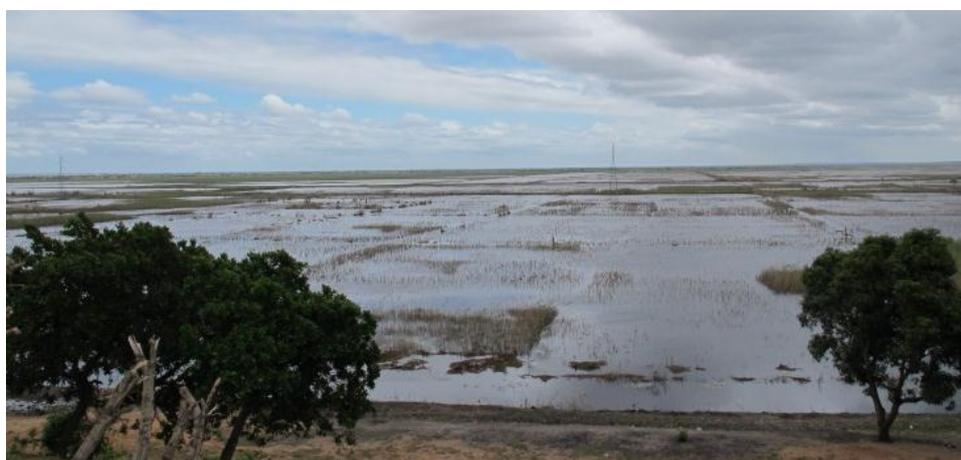
Many people in the Gaza province are dependent on agriculture for their livelihood. The flood destroyed their crops and also the possibility of sowing new crops as fields were still inundated (Photo 1).

Photo 1. Inundated fields Xai-Xai. Photo: Kaisa Nugin/Konstanze Kampfer

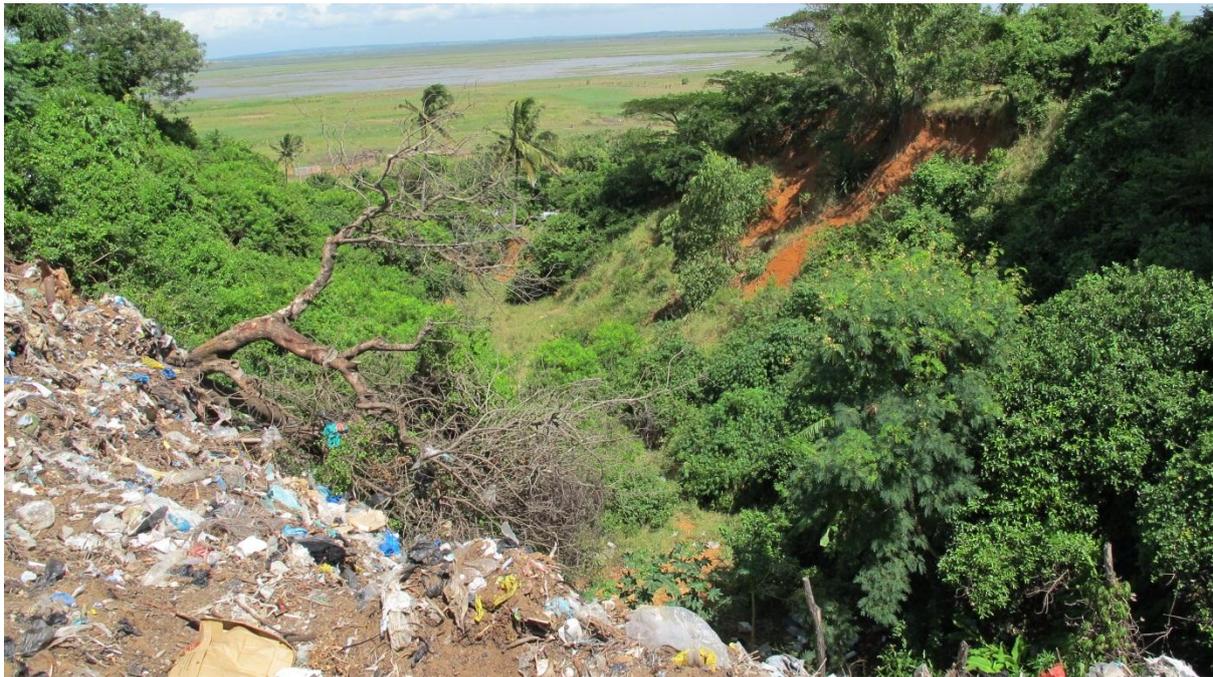
Waste is collected and transported to the official engineered dump site *Bairro Novo* established 2001. The dumpsite is a gorge that is filled up with waste and the site has no constructed liner or barriers. At the bottom of the dumpsite (gorge) there was a broken fence facing the lowlands. People and children from the area often come here to look for reusable things. Downstream from the dumpsite, at a distance of approximately 1 km, fields of rice, corn, sweet potato, beans and

banana are located. Photo 2 shows the dumpsite/gorge and behind-lying lowlands with fields still under water. The absence of a solid physical barrier implies that rain and water percolate through the waste on its way through the gorge towards the lowlands.

Photo 2. Official dumpsite Bairro Novo with lowlands and fields in the background. Photo: Kaisa Nugin/ Konstanze Kampfer

- ✓ Repair the dyke and implement maintenance strategies.
- ✓ Repair the fence that constricts the engineered dumpsite Bairro Novo or construct alternative barrier or protection e.g. a sand bank.
- ✓ The location of the dumpsite upstream from fields and close to housing is unsuitable. In the medium and long term perspective the engineered dumpsite should be reconstructed or replaced by a new dumpsite.

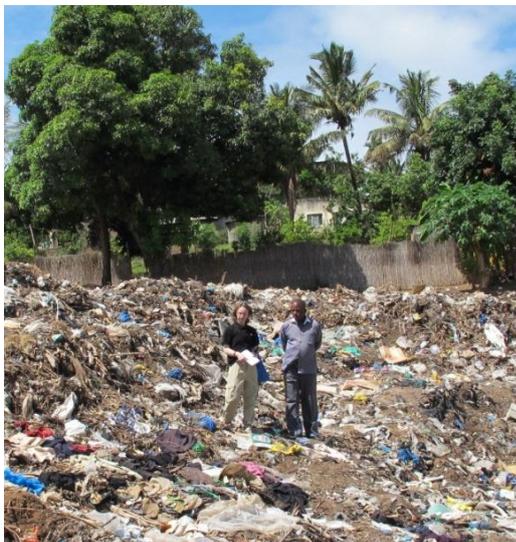
Photo 3. Official dumpsite Bairro Novo with house in the background. Photo: Kaisa Nugin/ Konstanze Kampfer

On both sides of the dump site houses were located close to the gorge, see photo 3. According to information given by Sergio Narciso Rojas, people found it positive that the gorge was filled up, as they were afraid the land was unstable. The households get drinking water from FIPAG so there were no wells for drinking water in use in the direct vicinity of the dumpsite. However, the location of the dumpsite poses risk of contamination of downstream areas used for cultivation. Furthermore, the dumpsite might be geotechnically unstable and create a false sense of security, in particular to communities scavenging on the site. As it is open to the public, safety issues should be considered. Beside the official dumpsite there are unregulated dumpsites. One is a dumpsite close to Bairro B and the market place Xiquema see photos 4 and 5 below. Waste was being burned uncontrolled in the area.

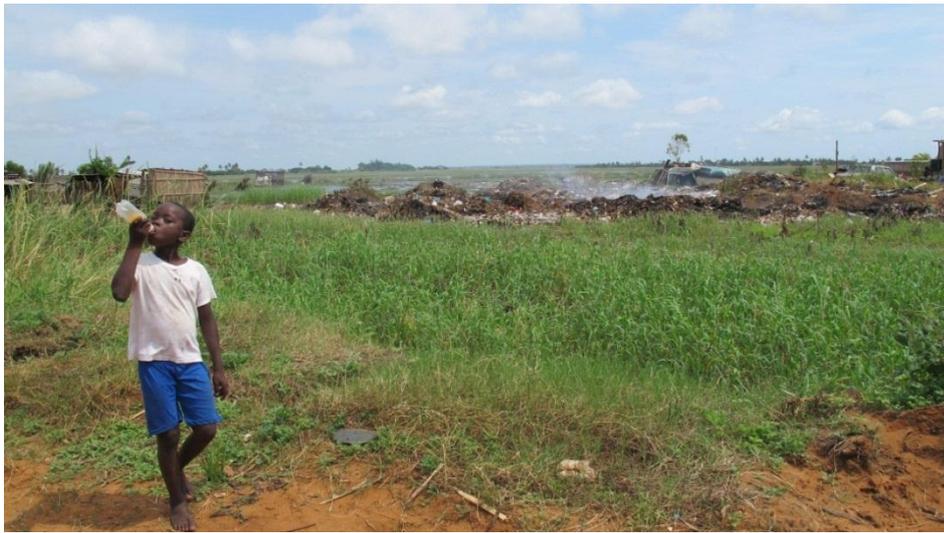
Photo 4. Unregulated dumpsite close to the market Xiquema. Photo: Kaisa Nugin/ Konstanze Kampfer.

The dumpsite poses a risk of contamination of the water and soil in the area and downstream. As the dumpsite is located in the open without barriers, waste has been spread during the flood. This waste poses a risk for human health for communities living nearby.

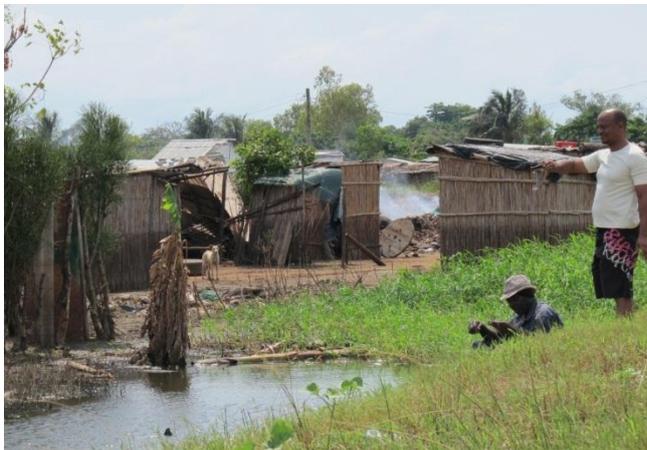
Photo 5. People dwelling and fishing close to the market and dumpsite Xiquema. Photo: Kaisa Nugin/ Konstanze Kampfer.

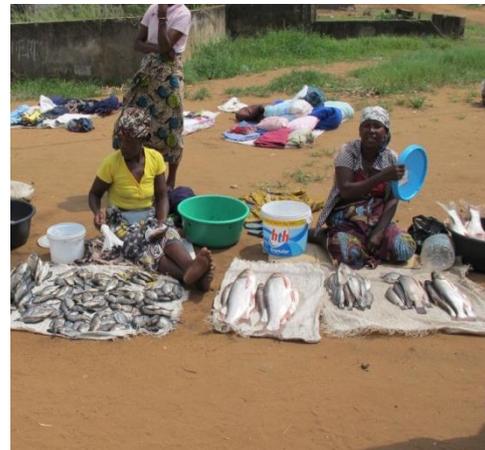
Photo 6. People selling fish at Xiquema market. Photo: Kaisa Nugin/ Konstanze Kampfer.

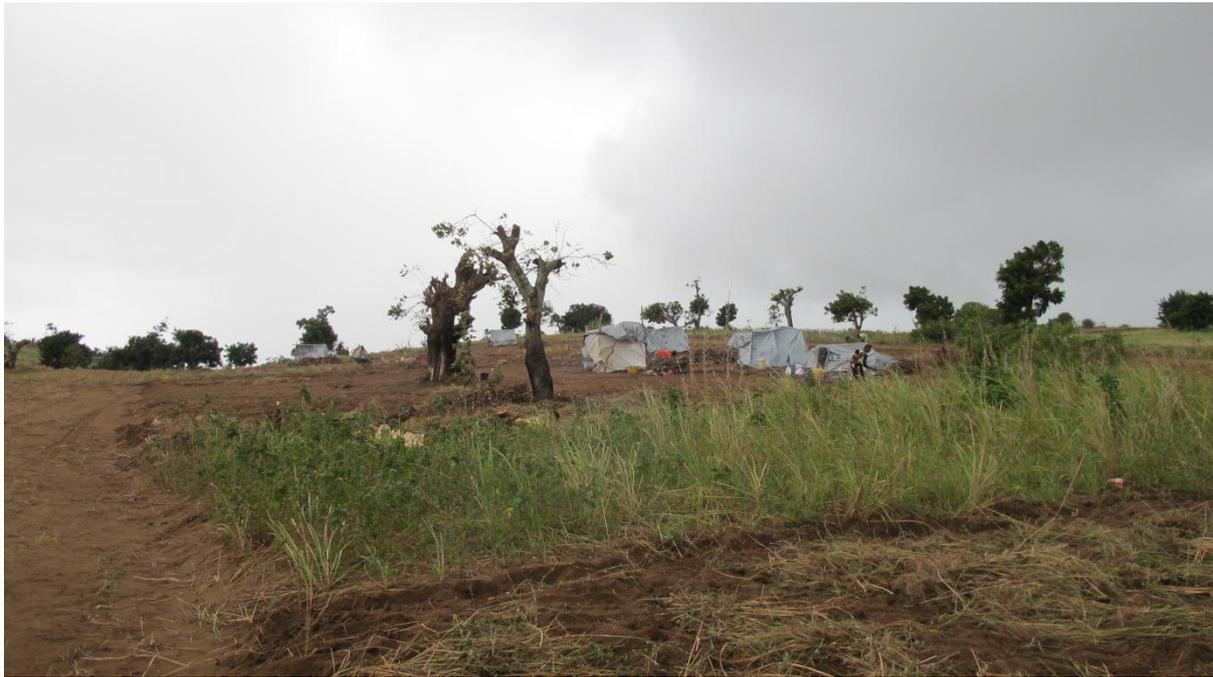
The resettlement called Marien Ngouabi B is located on higher grounds on the slope of a hill. The plots allocated were 20x20 meter and the area was planned for a total of 710 plots or 284 000m². Wood for construction of houses was expected to be transported from the Massingir area. An extensive transportation of wood from Massingir could cause secondary impacts such as deforestation and erosion.

Photo 7. Resettlement area called Marien Ngouabi B, Xai-Xai. Photo: Kaisa Nugin / Konstanze Kampfer.

Clearance of vegetation could cause erosion. Development of water and sanitation systems should correspond to the future population to mitigate environmental impact. If not collected, waste from the area could cause environmental contamination.

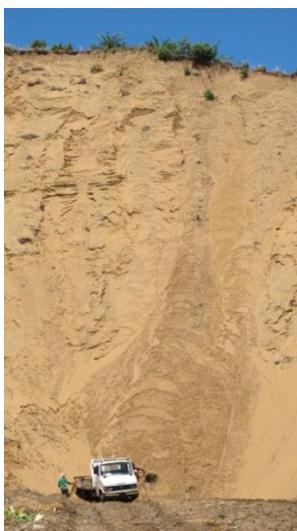
Photo 8. Sand mining. Photo: Kaisa Nugin/ Konstanze Kampfer

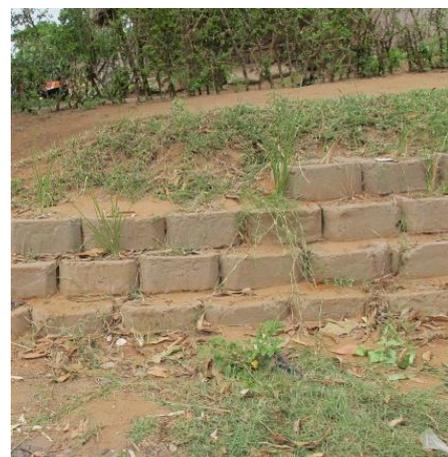
Photo 9. Example of erosion protection.
Photos Kaisa Nugin/ Konstanze Kampfer

In 2011, a Dutch project constructed concrete blocks for erosion protection (Photo 9).

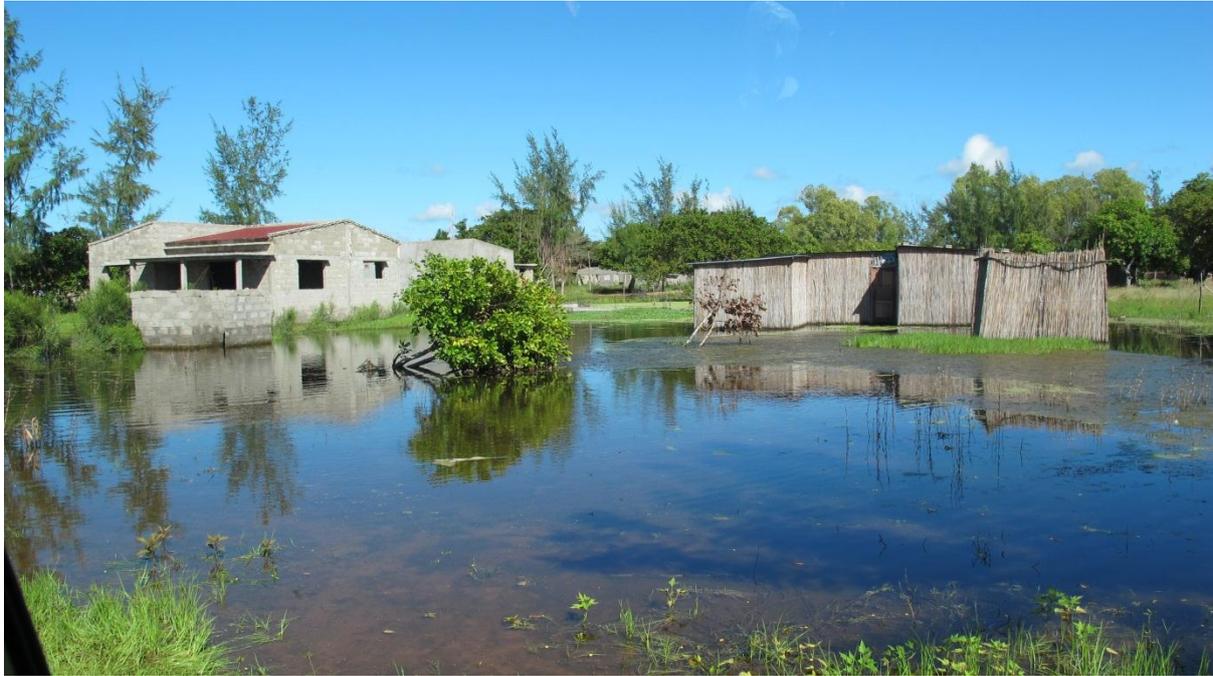
The geological composition of Mandlakazi district is calcareous bedrock which prevents water from infiltrating the soil – subsequently, these areas were still flooded.

Photo 10. Flooded area in Mandlakazi. Photo: Kaisa Nugin / Konstanze Kampfer

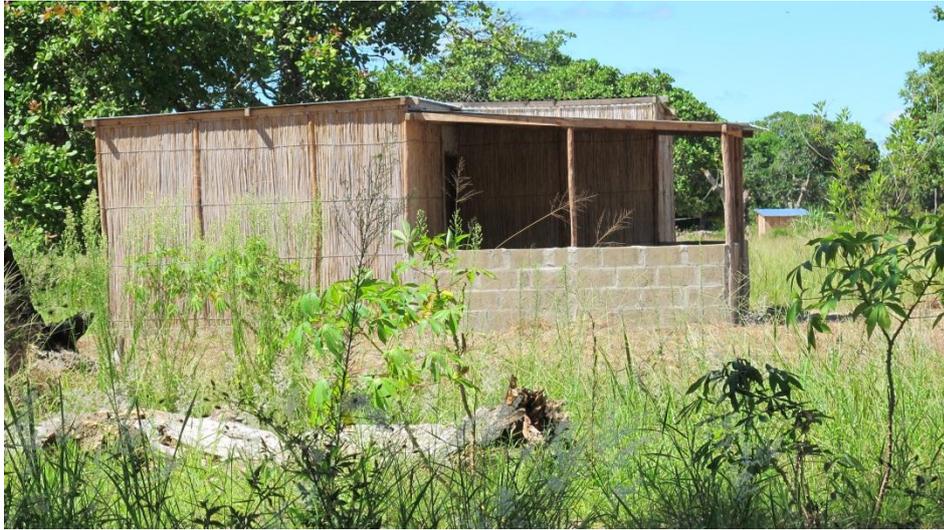
The resettlement area was planned to host a population of 1750 families and the plots were 30 x 40 meters large. The houses will be constructed using local materials such as straw (caniso), cement, nails, trunks, wire and a metal sheeting. A sample house is shown in Photo 11. Materials would be taken from areas such as Makaka and Chalala.

Photo 11. Example of a reconstruction house resettlement area Mandlakazi. Photo Kaisa Nugin/ Konstanze Kampfer.

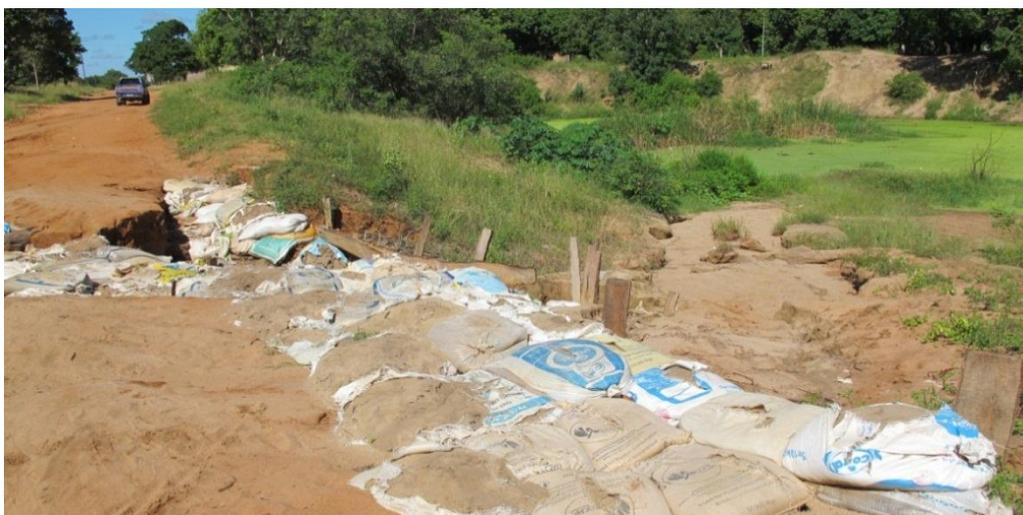
Waste is mainly buried or burned. In Mandlakazi an old sand mining site is used as dumpsite to fill up the excavated area. During the heavy rains the area was filled with water (Photo 12). The dumpsite poses a risk of contamination of the water and soil in the area and downstream. The practice of open burning of waste creates air pollution and poses health risks.

Erosion damaged the roads in the area. On the old sand mining site / the dumpsite had left the road with no support causing erosion to destroy the roadway.

Photo 12. Mandlakazi. The road and the old sandmining site/ dumpsite now filled with water and covered with green algae. Photo: Kaisa Nugin/ Konstanze Kampfer.

- ✓ Construct systems for water and sanitation in the resettlement area
- ✓ Assure that the water resource and capacity in the area is sufficient to supply the future population.
- ✓ Develop and implement erosion protection and drainage in resettlement area and along roads.
- ✓ Identify suitable areas for initially temporary and later permanent dumpsites.
- ✓ Develop waste collection systems including for the resettlement area.
- ✓ Develop and implement separate collection and treatment systems including for electronic, chemicals and other hazardous waste.
- ✓ Establish separate collection and treatment systems for healthcare risk waste at every health facility.
- ✓ Measures to protect the groundwater from leachate from the existing dumpsite to the groundwater should be taken.

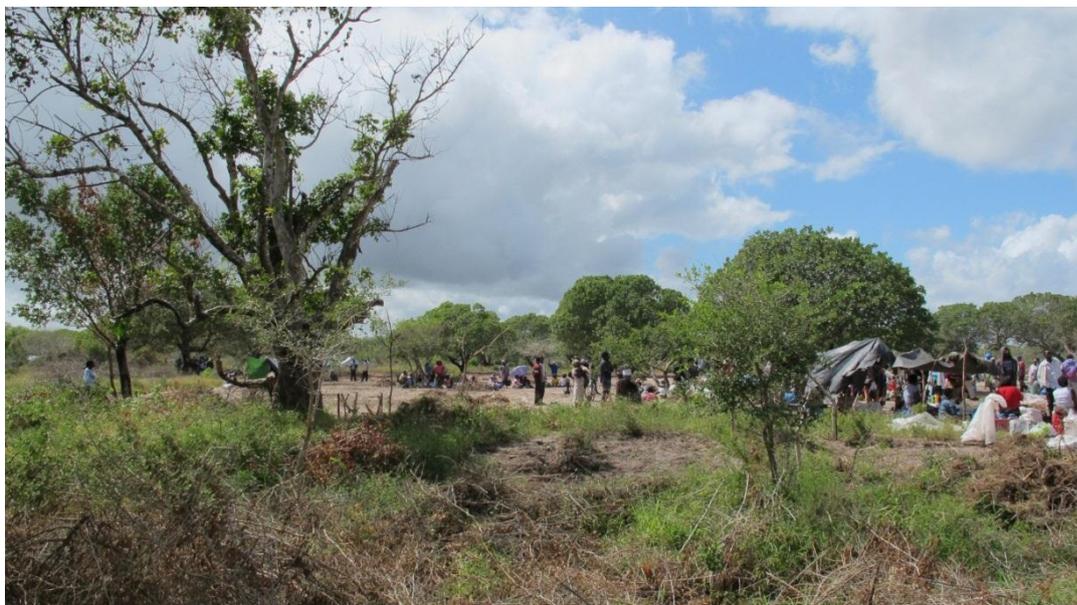
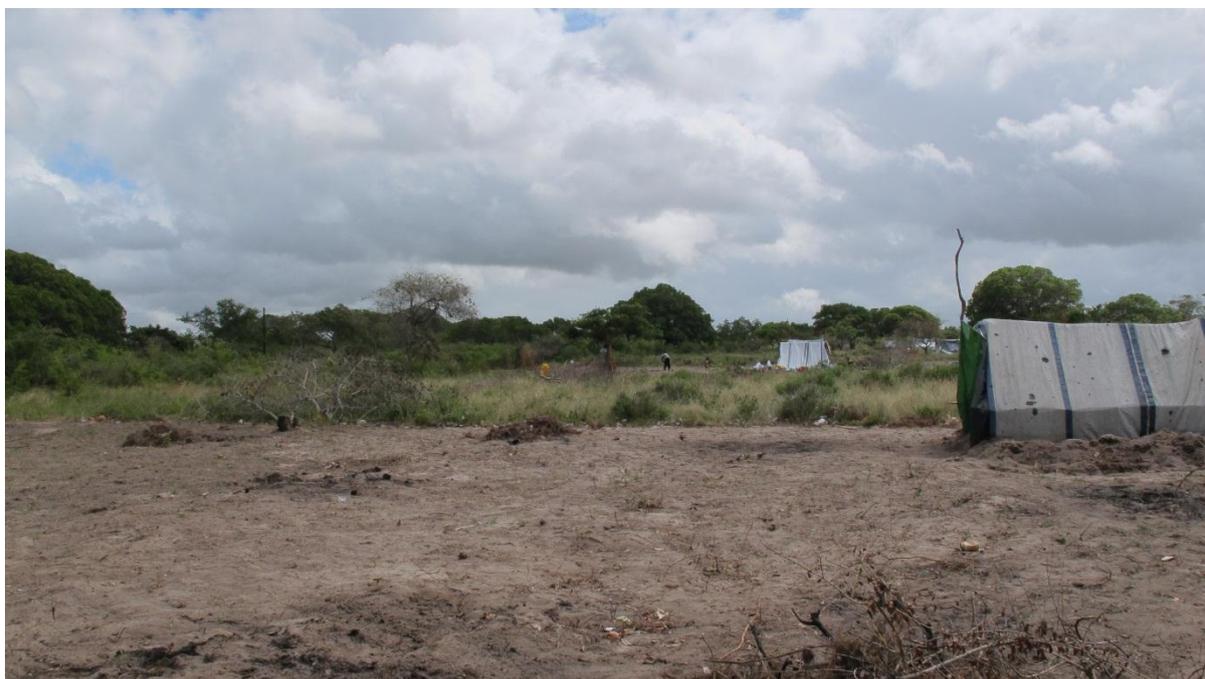
Photo 13. Chiaquelane resettlement area. Photo: Kaisa Nugin / Konstanze Kampfer.

No canalization system for drinking water was established and water was delivered in tanks to the resettlement area. As for construction material, clay is not found in the area and wood is a probable alternative for the construction of new houses. Wood was transported and delivered to the area

Photo.14. Chiaquelane resettlement area. Photo: Kaisa Nugin / Konstanze Kampfer.

Infrastructural development with clearance of vegetation could cause erosion. Development of water and sanitation systems must correspond to the future population in order to prevent and mitigate environmental impact. If not collected, resettlement area waste could cause environmental contamination.

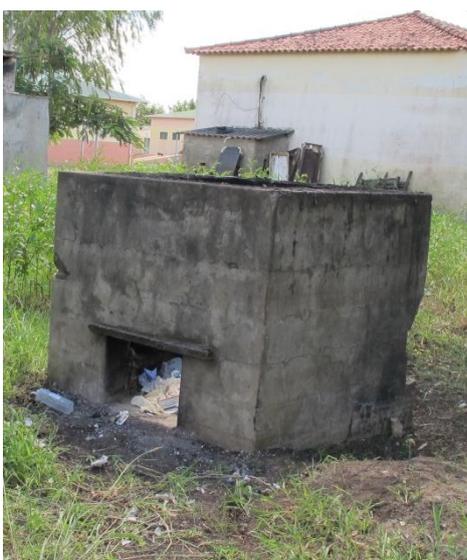
Flooding caused some damage to hospitals in Chokwe and Guija. Damaged medicines from both these locations were transported to the Chokwe hospital and incinerated. While the assessment did not conduct a full assessment of healthcare waste management practices, it was found that the simple batch burner in use in Chokwe does not correspond to minimum WHO healthcare waste management standards² (Photo 15).

The hospital handles health care waste locally through incineration. The hospital had a machine that disintegrated the waste prior to incineration but before the flood it was not functioning properly and now it is totally destroyed. In Chokwe there were two small concrete constructions in order to burn waste see photo 15.

*Photo 15. Incinerator in Chokwe Hospital.
Photo: Kaisa Nugin/ Konstanze Kampfer.*

- ✓ Supply communities with basic equipment for cleaning up the disaster waste.
- ✓ Damaged fertilizers must be handled and disposed of properly. Fertilizer bags must not be reused for other purposes as this poses risks to the environment and human health.
- ✓ Repair the sewage system in Chokwe including the health facility in order to prevent spreading of disease. Look into feasibility and opportunity for upgrading the (currently) uncontrolled treatment of the sewage before it reaches the river
- ✓ Identify suitable locations for dumpsites for waste: both for temporary or permanent use.
- ✓ Construct and organize a system for waste collection including the resettlement area.
- ✓ Develop and implement separate collection and treatment systems for electronic, chemical and other hazardous waste.
- ✓ Support sound healthcare waste management in adherence with WHO guidelines:

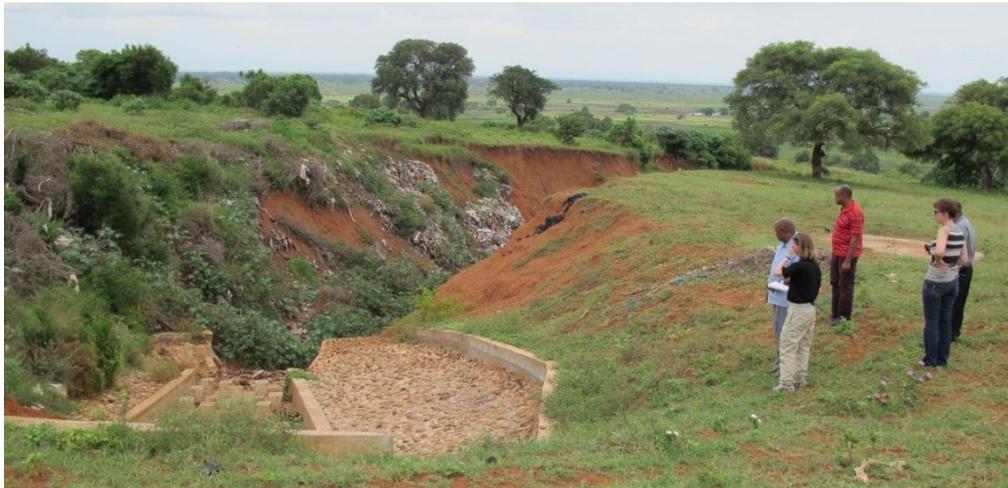
systems to handle runoff. The paved road between Chibuto- Chissane has a supplementary drainage system which caused heavy erosion at the drainage outlets points (Photo 16).

Photo 16. Drainage system for the road Chibuto-Chissane. Photo Jamisse Elidio.

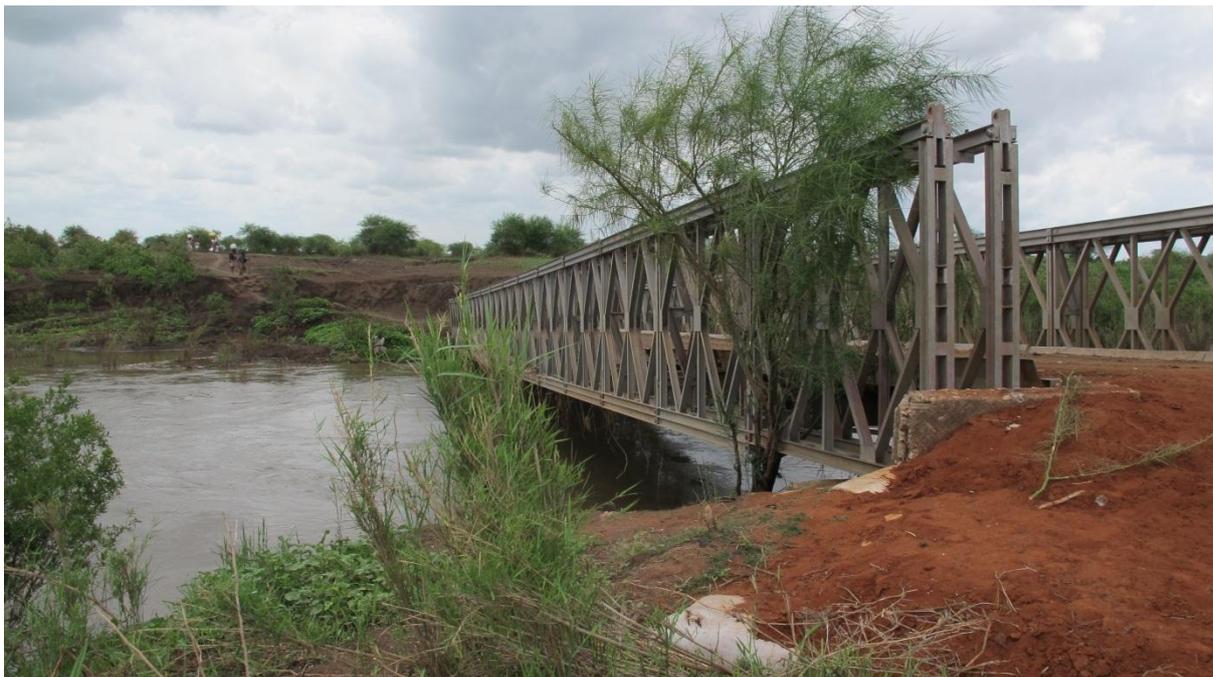
A metal bridge constructed two years ago connects the populated area with the fields. The bridge support structures had been affected by erosion and people and cattle had to ascend/ descend a slope on one side of the bridge.

Photo 17. Erosion damage of a metal bridge. Photos Kaisa Nugin/ Konstanze Kampfer.

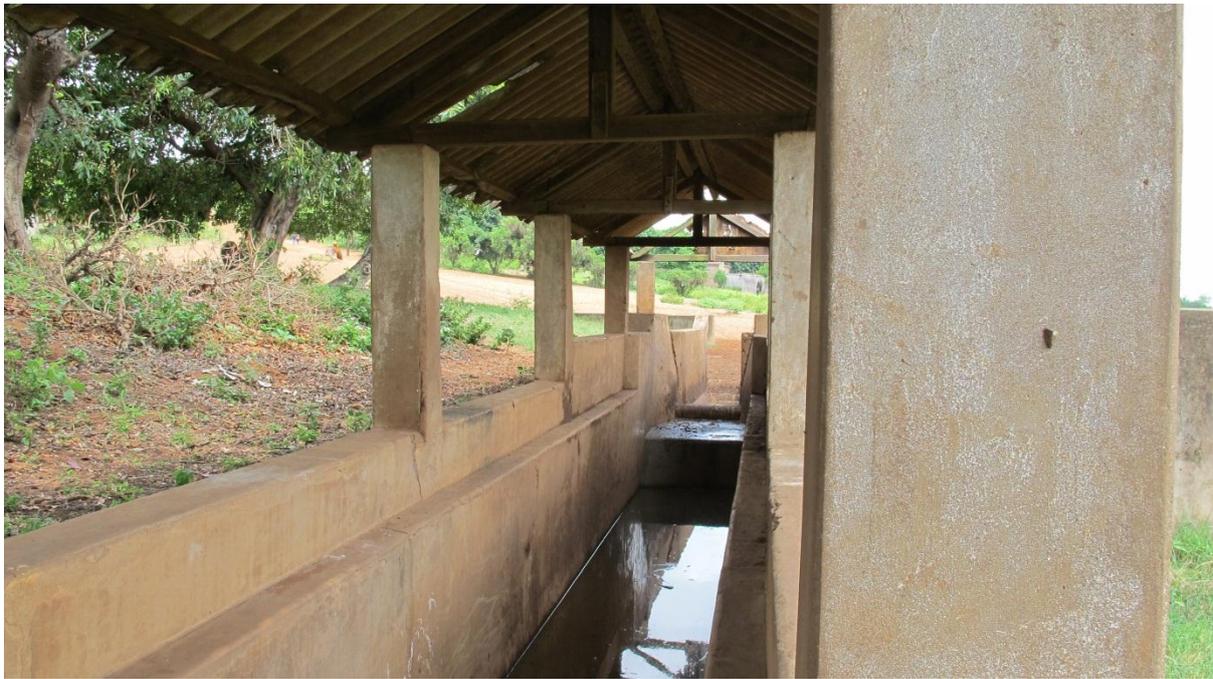
According to information provided there are no larger storages of pesticides or fertilizer in the area. Insecticides are used for treatment (cleaning) of larger animals. The animals, cattle, passes through basins filled with an insecticide solution (Photo 18). During the flood solution from three or four basins had been washed out. The effluent was suspected to have caused the death of fish that were observed 2-3 km downstream in the river. Information provided at the SAIDE was that the product used is Milbitraz TR.

Photo 18. Washing basin for animals, Chibuto. Photo: Kaisa Nugin/ Konstanze Kampfer.

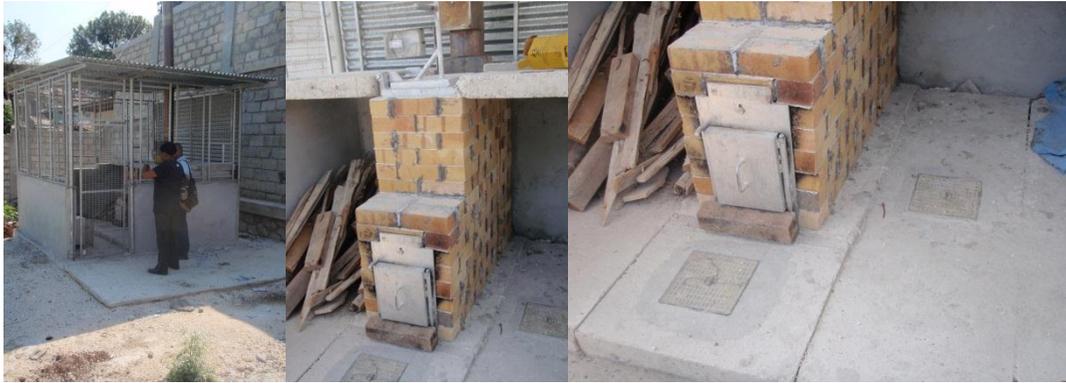
Photos 19- 21 . De Montfort incinerator that remained after the earthquake 2010 in Port au Prince, Haiti. The incinerator and chimney made of brick. Below the incinerator is space for the remaining ashes and when this is filled the incinerator need to be moved or replaced. Photos MSB.

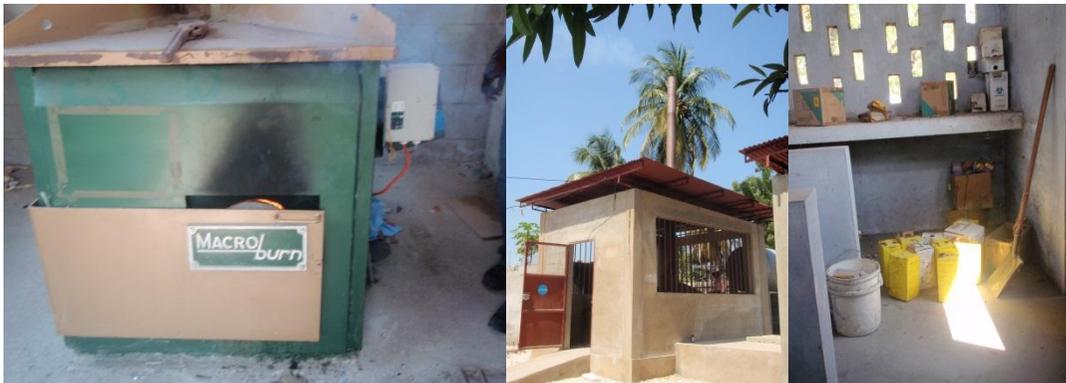
Photos 22-24. Example of oil fuel incinerator, Haiti 2010. This incinerator use oil but LPG and biogas could also be used as fuel. Below the incinerator is space for the remaining ashes and when this is filled the incinerator need to be moved or replaced. The shed also offers protected storage space. Photos MSB.
