Assessment Mission of the Shinkolobwe Uranium Mine

Democratic Republic of Congo,
November 2004

Compiled by the Joint UNEP/OCHA Environment Unit

This summary report is based on the five expert technical reports prepared by the assessment team members following the October – November 2004 mission to the Democratic Republic of Congo (DRC). These reports include: mining, radiological, environmental, health and humanitarian.

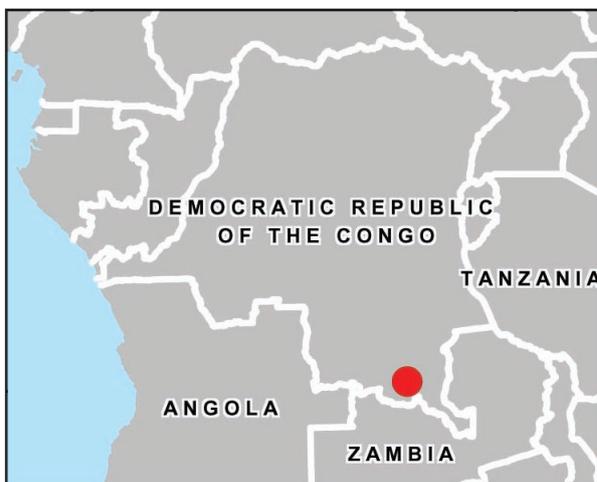
Shinkolobwe former uranium mine

Source: UNOSAT, 2004

Image credit: USGS, Univ. of Maryland
Image Processing: UNOSAT

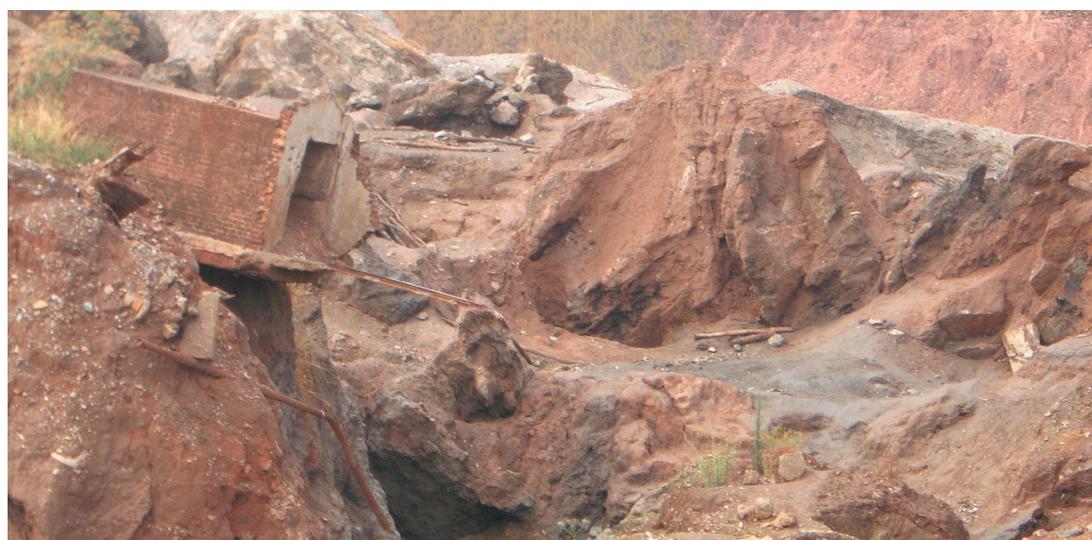
The mission team found that the collapse resulted from an anarchistic exploitation of the site with no respect for mining safety regulations. The grounds remain unstable due to unskilful and rapid underground excavation and poorly managed mineral waste deposits. The risk of further collapse, therefore, remains very high.

Rapid and poorly managed mining has led to unstable grounds.

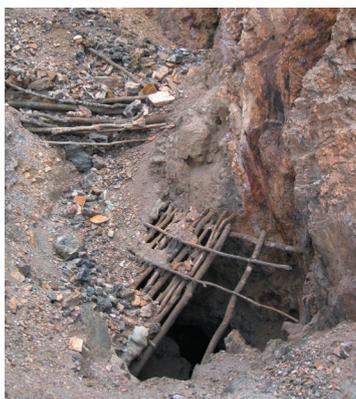
Poor mining practices expose workers to undue risks.

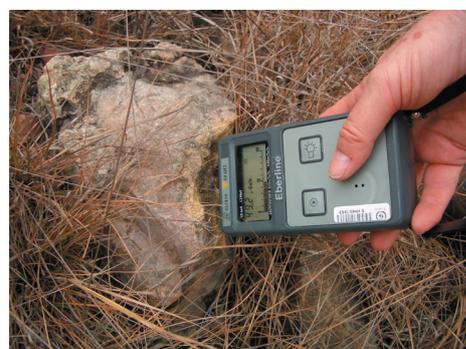
Readings of gamma dose rates were carried out throughout the site.

Readings of ambient gamma dose rates and 'suspected' areas were taken with specialised measurement equipment to establish the site's natural background radiation levels. At locations where radiation readings were higher, a larger number of readings were carried out to establish the size of the affected area. Personal exposure measurement equipment was worn during fieldwork to establish the levels of radiation exposure actually experienced on site. The two most potentially exposed team members, based on their assigned tasks, wore the dosimeters.

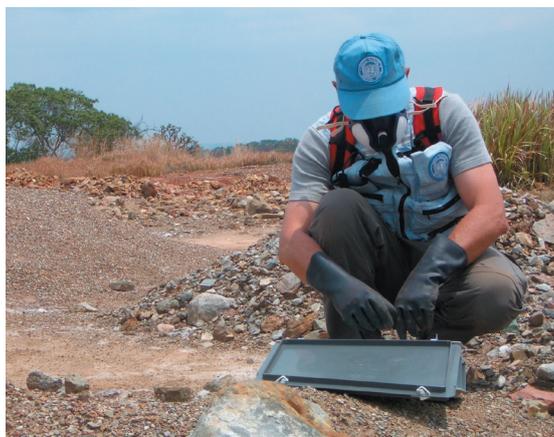
Soil sampling can reveal potential heavy metal contamination in the area.

The samples were taken within the whole of the perimeter of the mine, in particular (i) in each area of recent mining activity; and (ii) at sites marked by increased radioactivity.

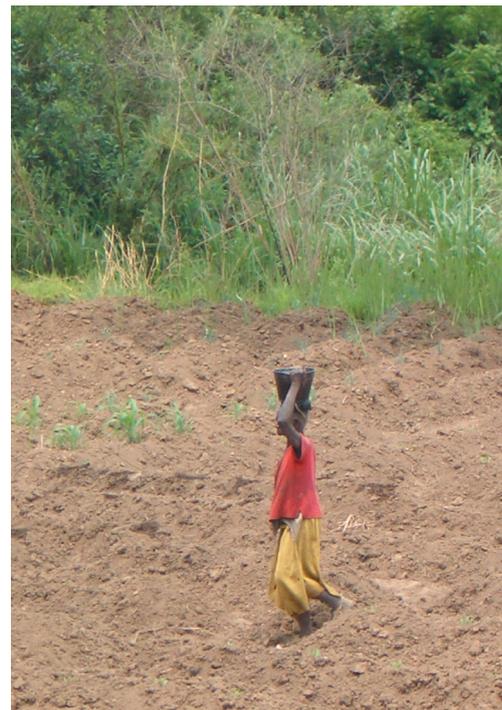
Agricultural land near the mine site provided some of the village's food needs. Soil samples were taken from the area for analysis.

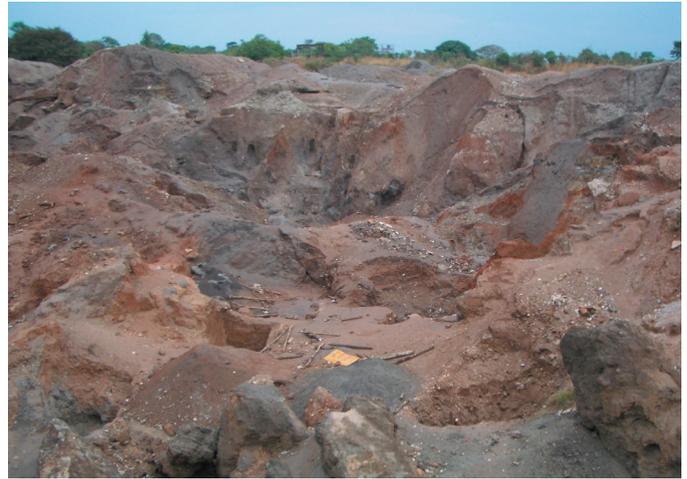
The collapsed tunnel is located approximately 3 metres behind the small yellow sign.

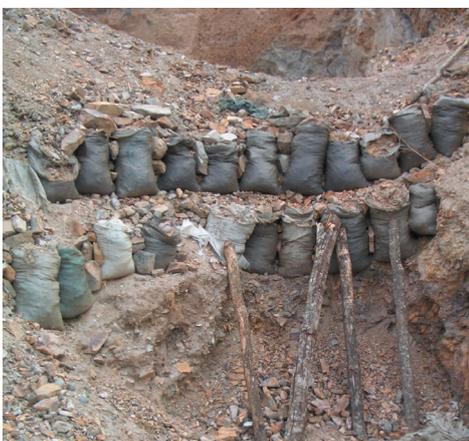
Rudimentary methods were used to prevent slippage.

Mining activities were carried out with rudimentary tools: picks, shovels, battery operated flashlights, woven plastic bags, rope, etc. Local wood was cut down and primarily used to protect rock cuttings and entrances to the wells.

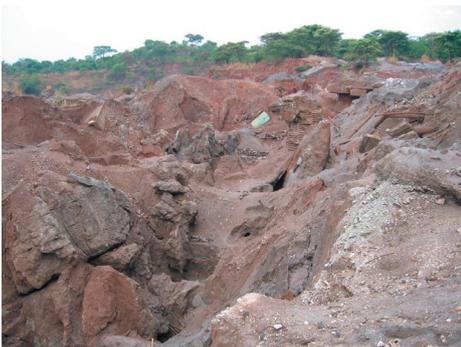
The site, a large crevasse with many holes, is highly unstable.

underground work has greatly weakened the area, increasing the risk of further collapse. The debris and mineral waste placed near the mouths of tunnels, sometimes supported by wood or bags, encouraged potential slippage. Enormous cracks appear on the ground, indicating great instability of the underground works.

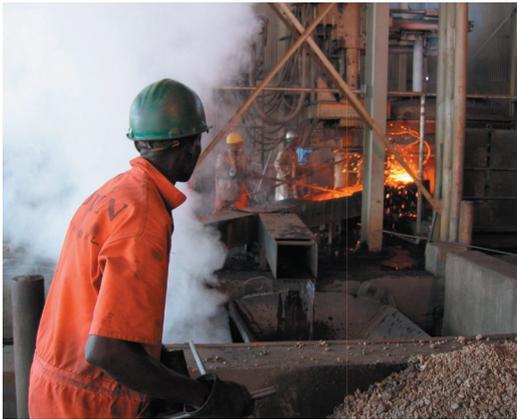
Foundries in the Likasi area were visited by the mission team.

Fifty kilogram bags were loaded on trucks at Shinkolobwe bound for Likasi. A relay village had been established on the route for various supplies and purchases. Transport routes leaving the site show low levels of radiological contamination caused by falling ore dust from trucks.

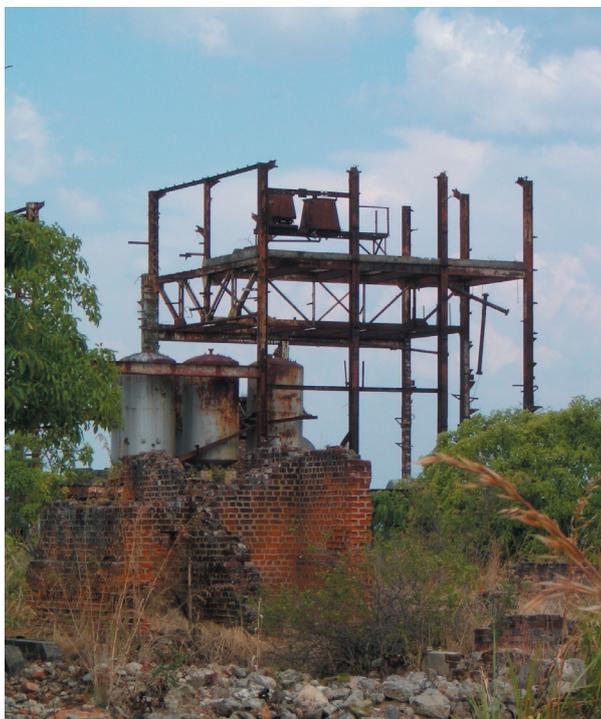
Observation of the former mine and mill area revealed the presence of remnant plant items and infrastructure including buildings, concrete foundation slabs and decantation vessels. Inadequately contained uranium mill tailings with no erosion covers were found, as well as rehabilitated sedimentation ponds.

Little of the original uranium mine infrastructure remains.

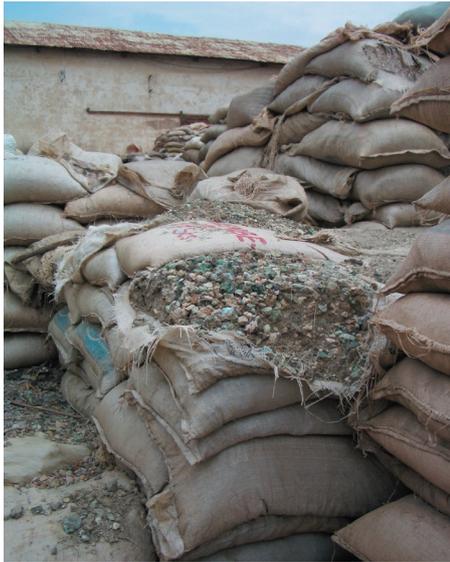
The WAMICO, SOMIKA, and Group BAZANO depots were visited in the Likasi area, as well as the Tshalumkambo depot. Each of these depots at one time stored ore bags from Shinkolobwe, though no bag was found at the time of the visit. The storage area at both WAMICO and Tshalumkambo is rudimentary. Bags are exposed to rain and stored directly on the ground where a concrete slab should be. This could lead to heavy metal leaching and potentially contaminate the ground water.

Poor storage of mineral ore can lead to ground pollution through leaching.

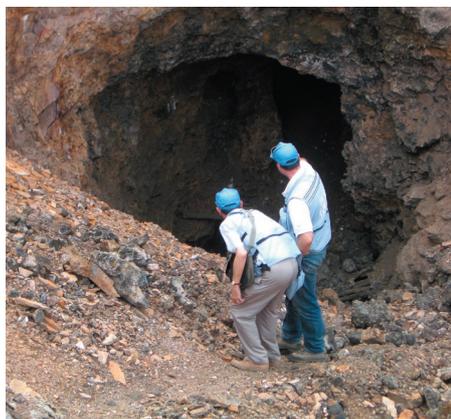
Mission team members assess the stability of a ground tunnel.

This type of extraction promotes ground instability, endangering the people involved in the activity. The focus of miners on heterogenite contributed to a rush by the rural poor to adopt this activity, accentuating the risk of accident. The physical safety aspects of the site presented a severe risk and prevented examination of underground workings. Signs of future mine collapse are evident, blocks are detaching themselves from the walls on the southern side, open cracks attest to the permanent instability of the grounds.

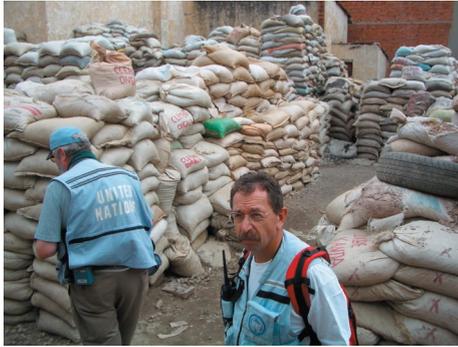
Mineral ore bags are poorly stored in several Likasi area depots.

8. Improper ore storage could lead to ground water contamination

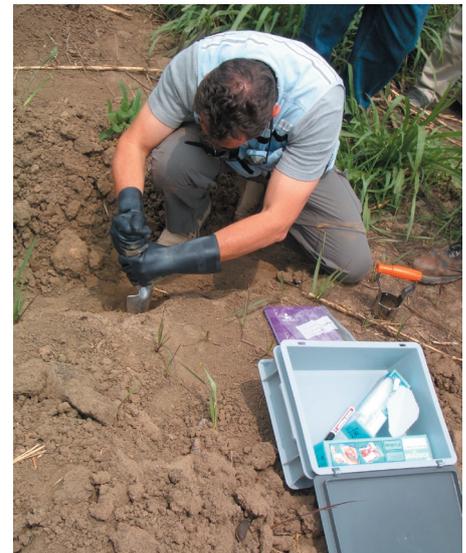
A complete assessment would allow for a full site characterisation.

It is strongly recommended that a complete assessment and characterisation of Shinkolobwe be implemented. This would provide a full assessment of the site's radiological and environmental risks, as well as a long-term management and remediation plan.

As Shinkolobwe has never been cleaned or rehabilitated, a complete decontamination of the site is advisable. Within such a framework, whose diagnosis remains to be made, the abandoned infrastructures, tailings and mineral waste rock could be deposited in the quarry following a site clean-up. The remaining contaminated residues should be sequestered according to best waste safety and management practices, such as embankment and topographic remodelling. A monitoring system with respect to potential radiation emissions would have to be established for a minimum period of 10 to 20 years.

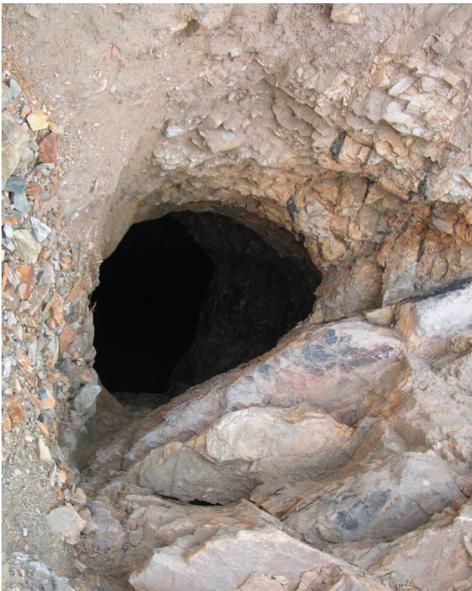
Proper enforcement of regulations would avoid creating the dangerous work situation seen above.

An inter-agency monitoring group in connection with artisanal mining should be set up in Kinshasa and Lubumbashi. The group would include the United Nations Development Program (UNDP), the International Labour Office (the ILO), UNICEF, WHO, OCHA and MONUC. The Kinshasa group would work in collaboration with the relevant governmental organisations to make follow-up recommendations to this report and support the Government in defining an integrated intervention strategy and action plan: Ministry of Mining (SAESSCAM and Environmental Protection Division); Health; Primary, Secondary and Professional Education; Environment and Conservation; and Solidarity and Humanitarian Affairs. This plan should include:

- a) access to basic services by the local population;
- b) a technical and organisational support framework as well as work health and safety aspects for artisanal miners; and
- c) the prohibition of child labour at mine sites.

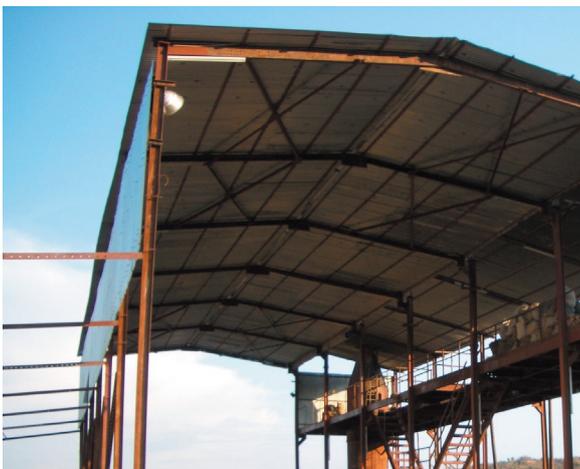
New smelting plants are being built in the Likasi area.
