**United Nations Disaster Assessment & Coordination (UNDAC)**

**COTE D'IVOIRE  
URBAN HAZARDOUS WASTE DUMPING**

**11-19 SEPTEMBER 2006**

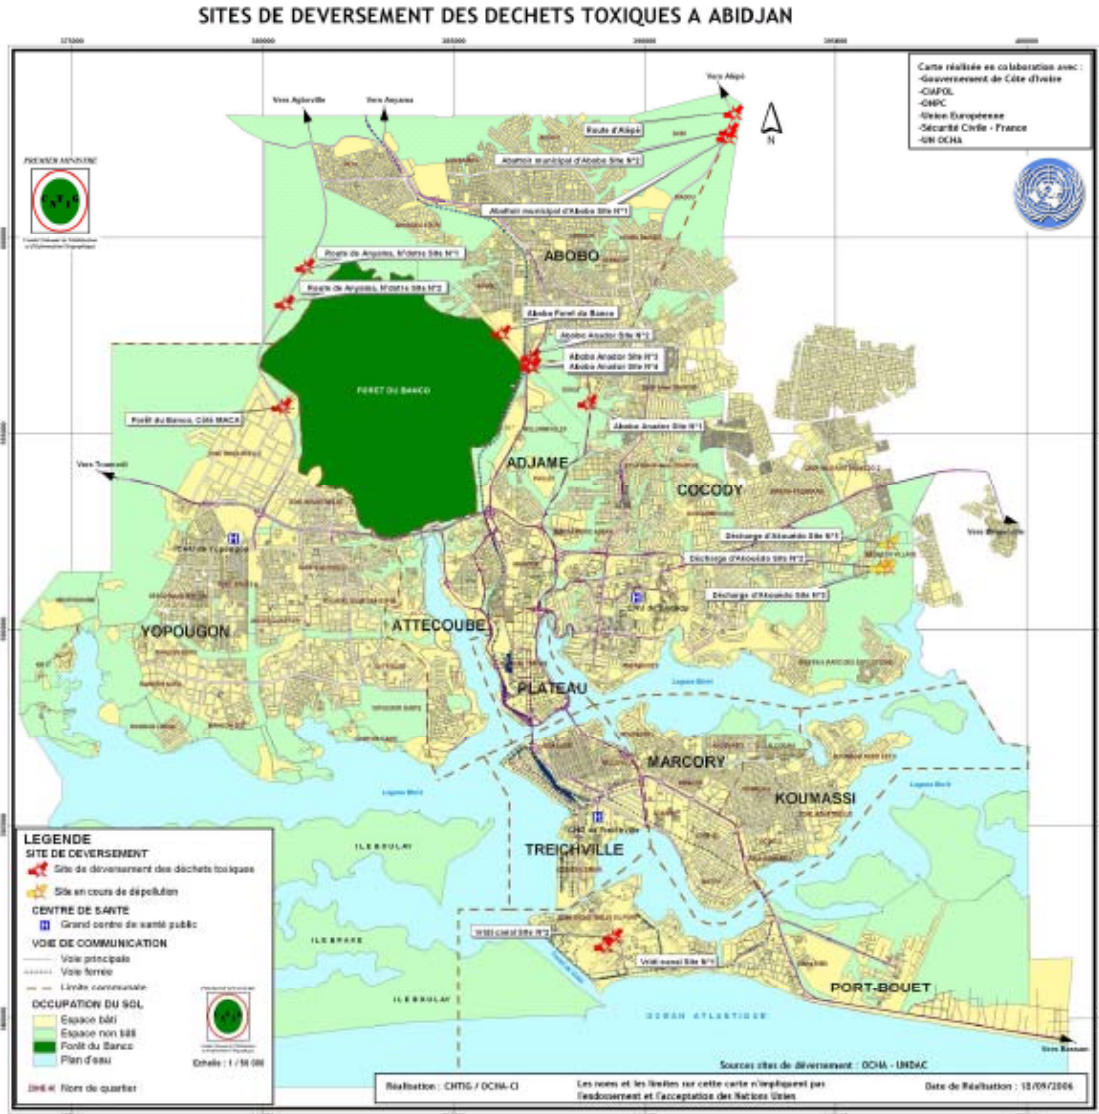
## ANNEX VI MAPS OF CONTAMINATED SITES IN ABIDJAN

Prepared by CNTIG in collaboration with the government of CDI, CIAPOL, ONPC (Office National de Protection Civile), European Union, French Civil Protection, and OCHA. Site locations and photos by UNDAC.
